# ENVIRONMENTAL AUDIT REPORT, 1-3 HIGH STREET YARRAVILLE - PHOTOS

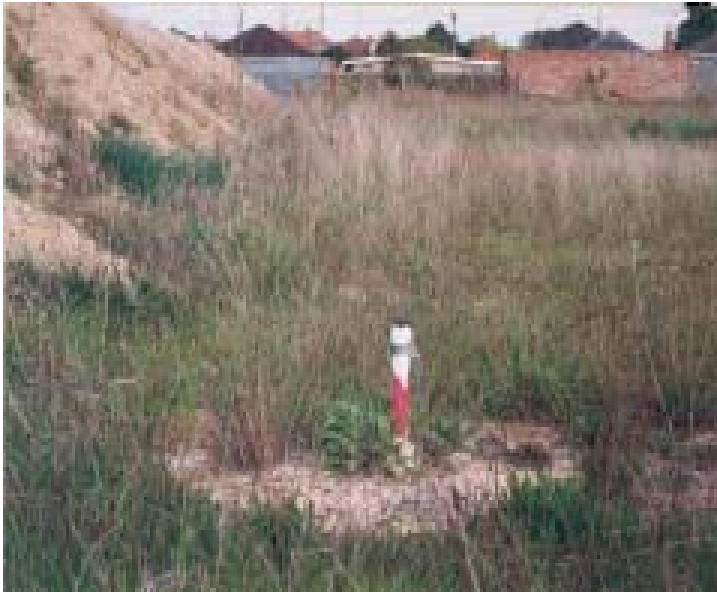
1. Site collection prior to remediation (15/5/01)

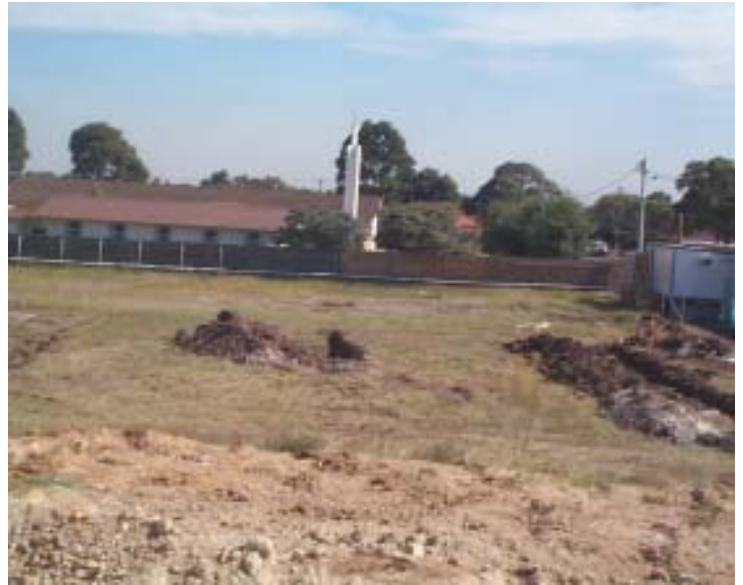
2. Excavation of test pits to identify edge of quarry (10/4/02)

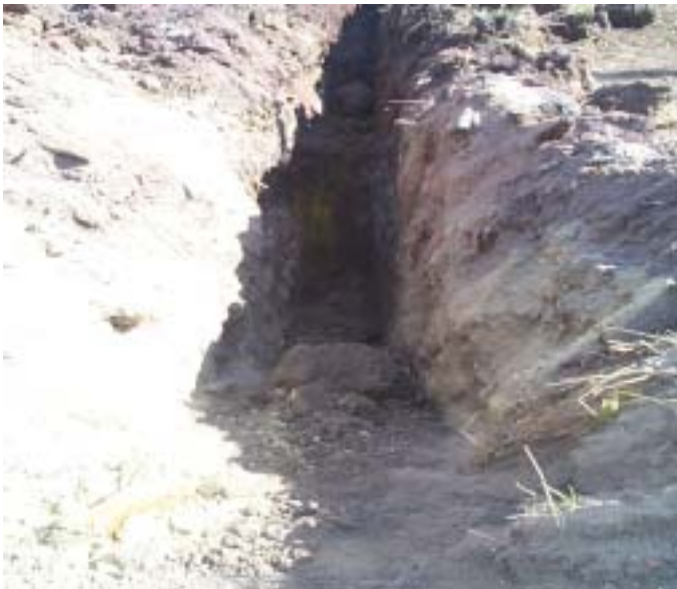
3. Excavation of test pit to identify edge of quarry (10/4/02)

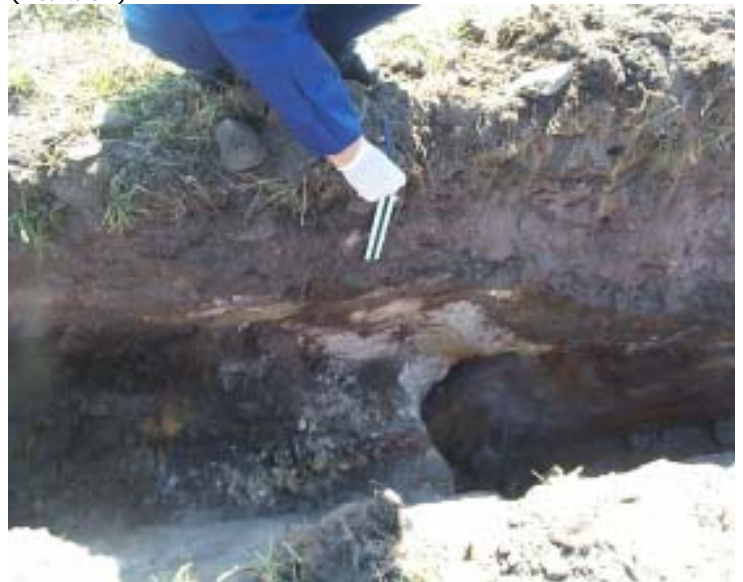
4. Test pit showing edge of quarry (10/4/02)

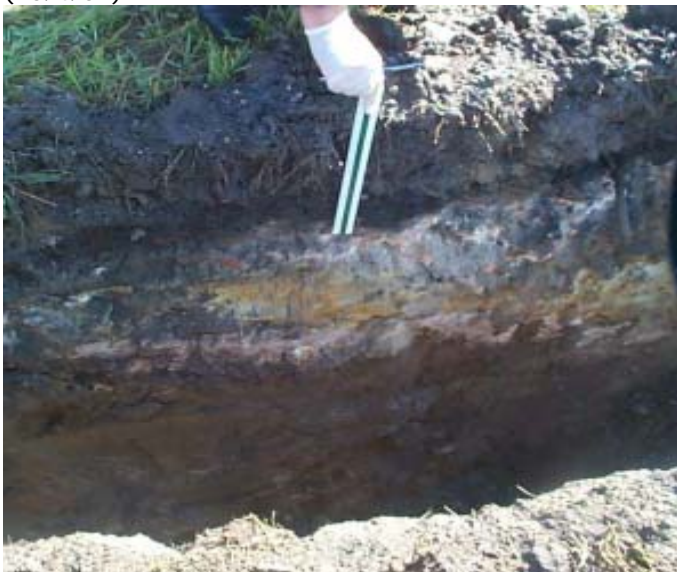
5. Excavation of test pit showing basalt at edge of quarry (10/4/02)

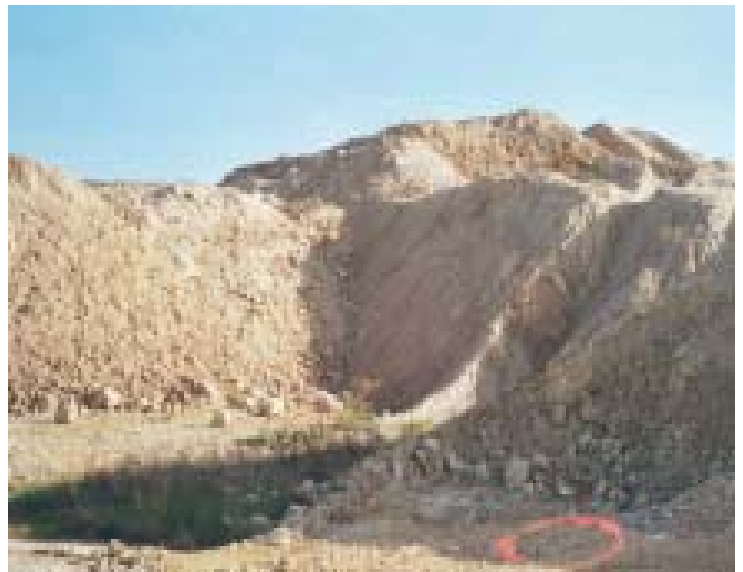
6. Stockpile used for cap construction (6/5/02)

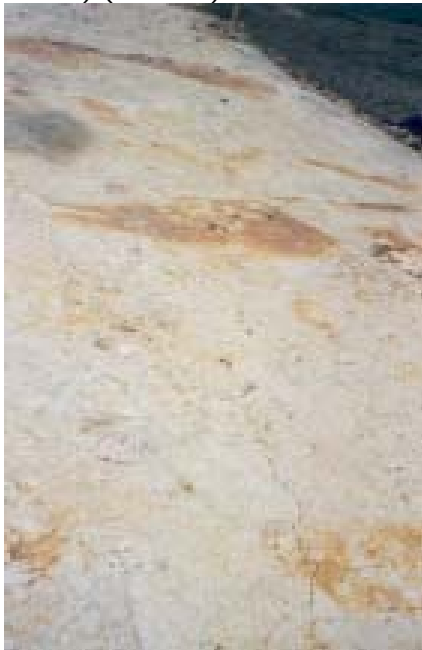
21. Minor surface cracking in finished clay cap (cracks surficial only) (31/7/02)

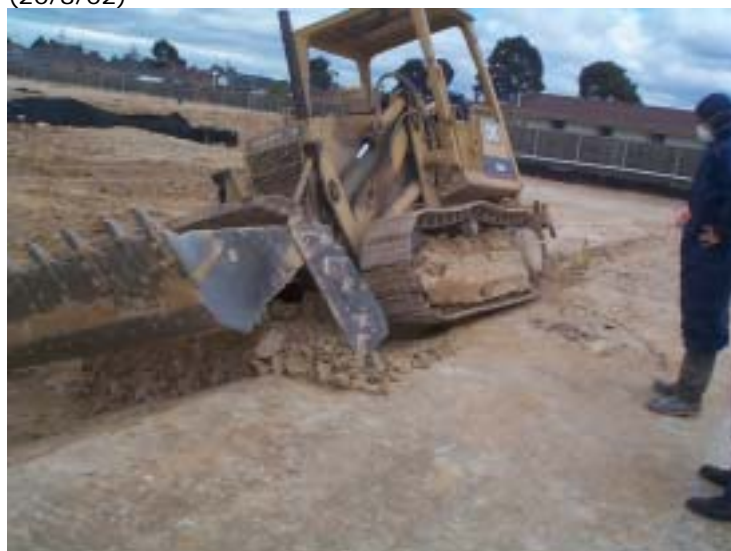
39. Scraping edge of clay layer to check for lamination (20/8/02)

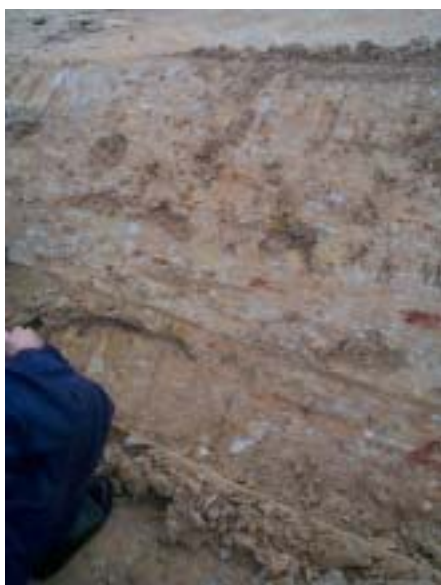
40. Checking for lamination in compact clay profile (no evidence found) (20/8/02)

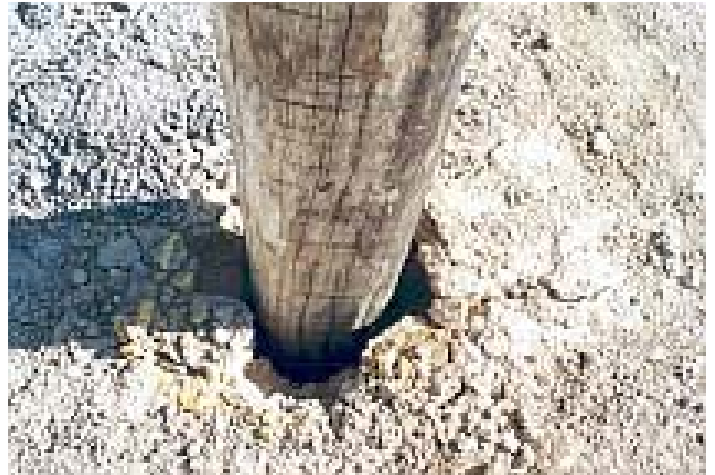
42. Typical cracking around timber pile following driving of pile (12/2/03)

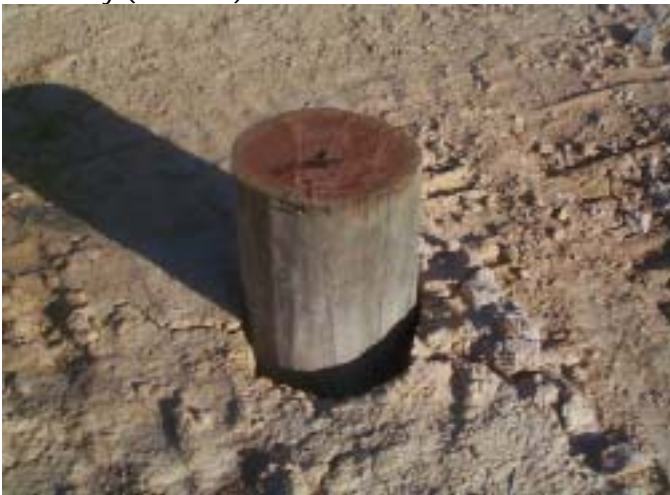
43. Typical pile showing gap and cracking near surface (25/9/02)

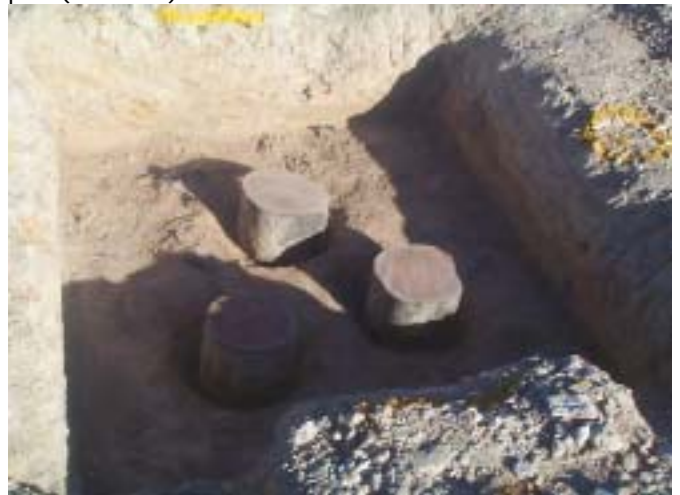
44. Excavation for construction of pile cap (note cracking and gap around pile reduced after excavation – ie cracking appears surficial) (25/9/02)

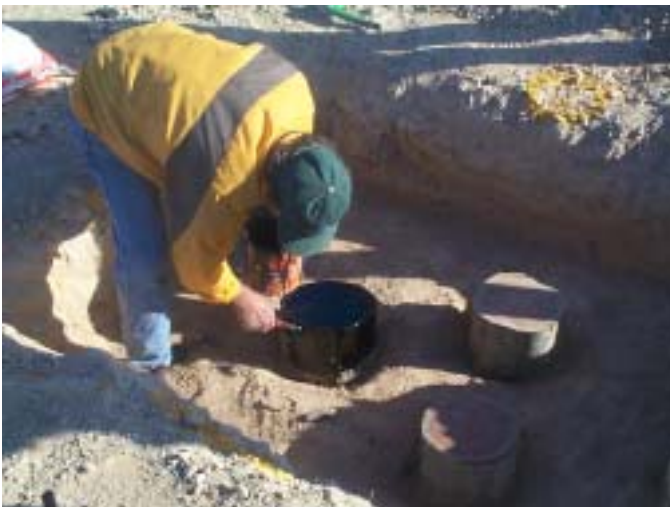
45. Bituminous paint to protect piles (25/9/02)

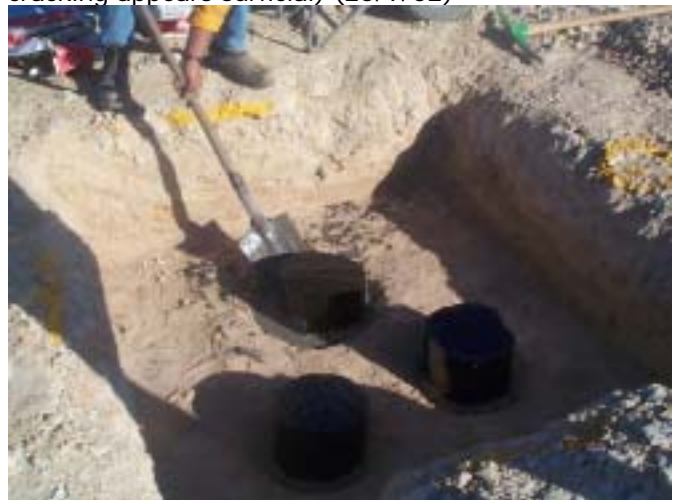
46. Placement of expanding grout around piles to seal gap (25/9/02)

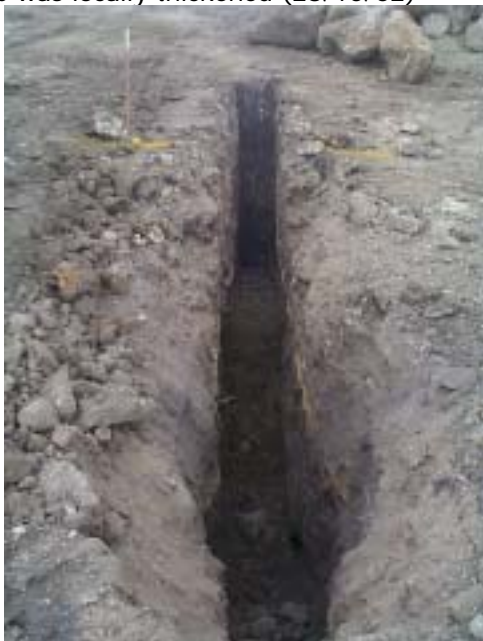
54. Trench to locate quarry edge east of Grid 11 (yellow line marks quarry edge) (28/10/02)

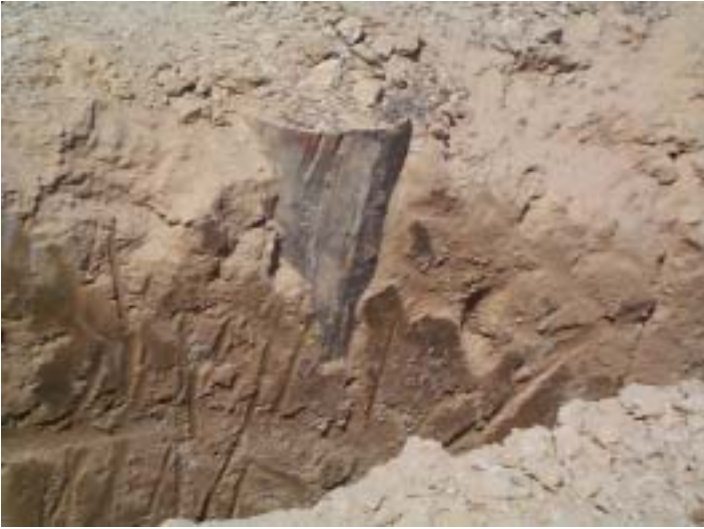
56. Pile adjacent to service trench (note limited depth of any cracking or gap around pile) (14/11/02)

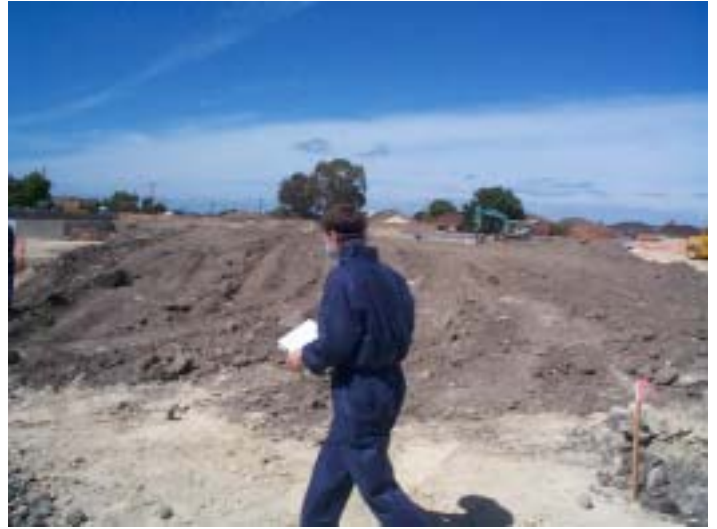
57. Stockpiled contaminated soil from trench excavations (14/11/02)
