TIMBER PRODUCTION ON PUBLIC LAND 2003

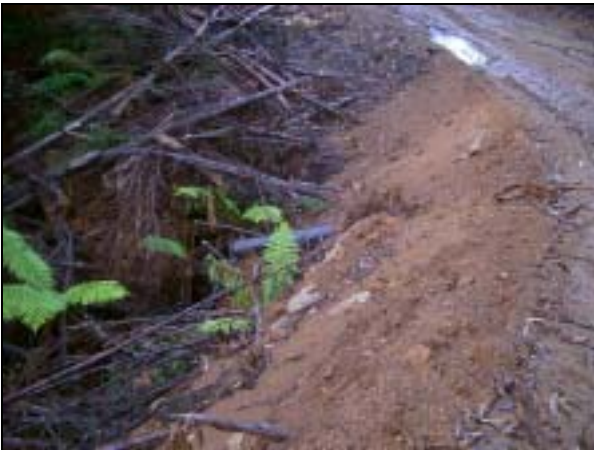
Photo 1. Steep fill batter installed next to road with undersized culvert.

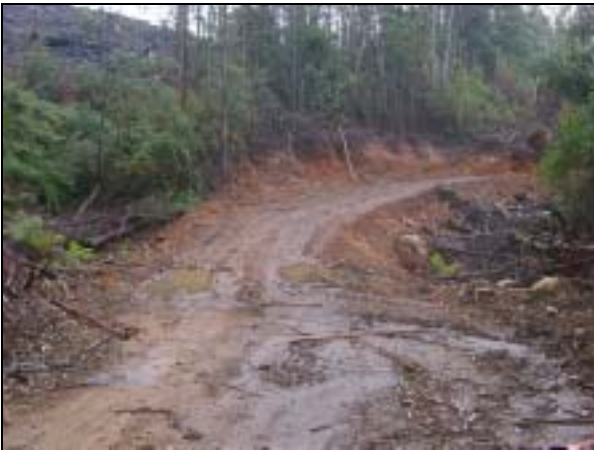
Photo 2. Section of the permanent road shown in Photo 1 constructed without table drain and proper cross-slope or crown.

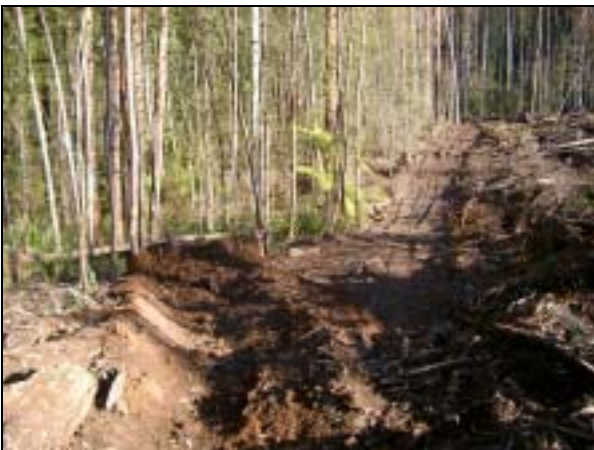
Photo 3. Boundary track with bar and breach pushed beyond coupe boundary.

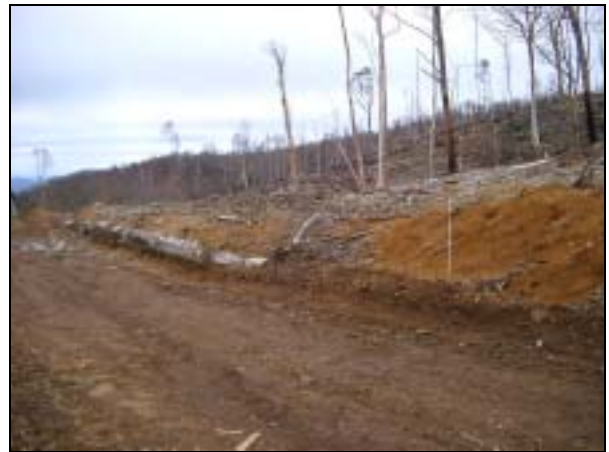
Photo 5. Unrehabilitated log landing condition (centre of view) signed off as having been rehabilitated.

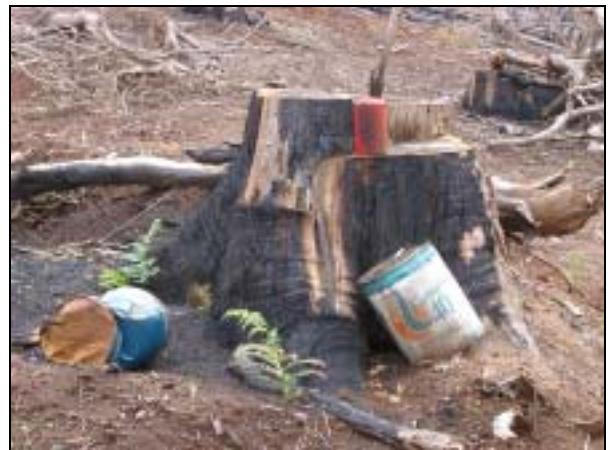
Photo 6. Litter present at coupe.

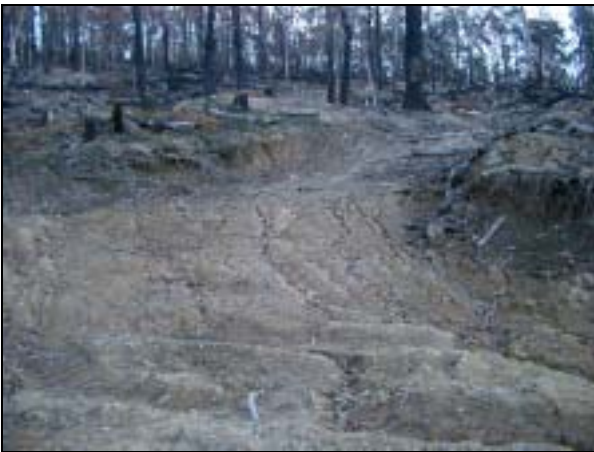
Photo 8. An example of erosion on an internal road.

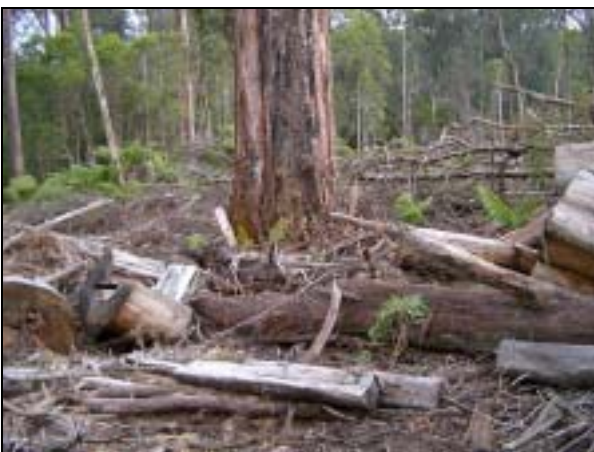
Photo 9. Slash accumulated around a habitat tree contrary to management prescription requirements.

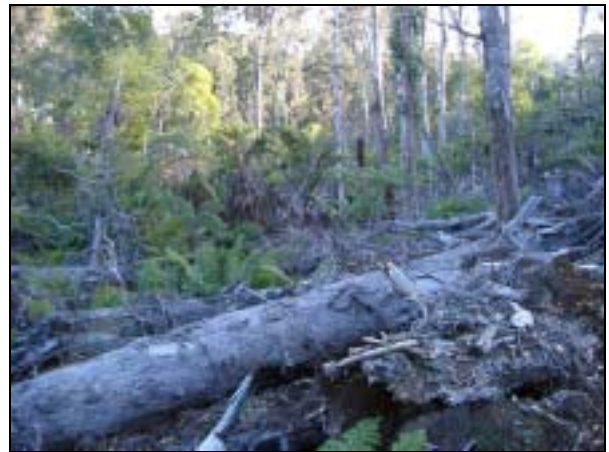
Photo 11. Excessive slash accumulated in filter strip.

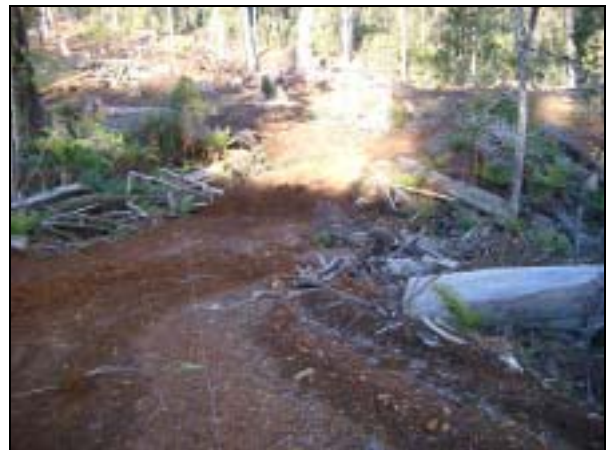
Photo 12. Track installed across filter strip by DSE without approval.

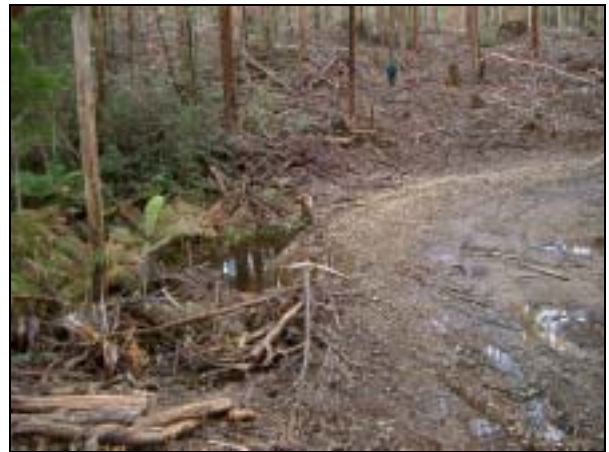
Photo 17. Road culvert blocked by damage from excavator. Note water running across road.

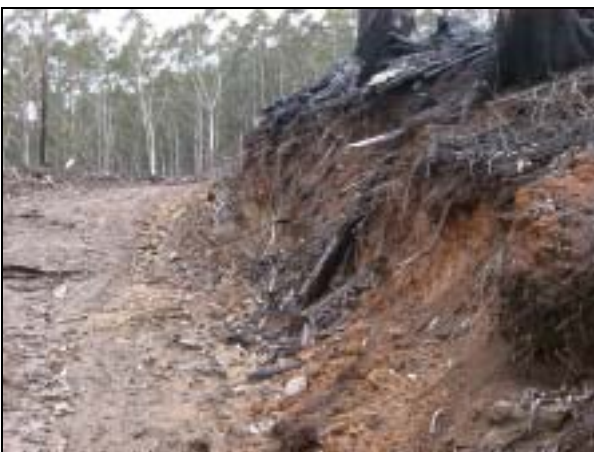
Photo 15. Roadside batter finding its own angle of repose.

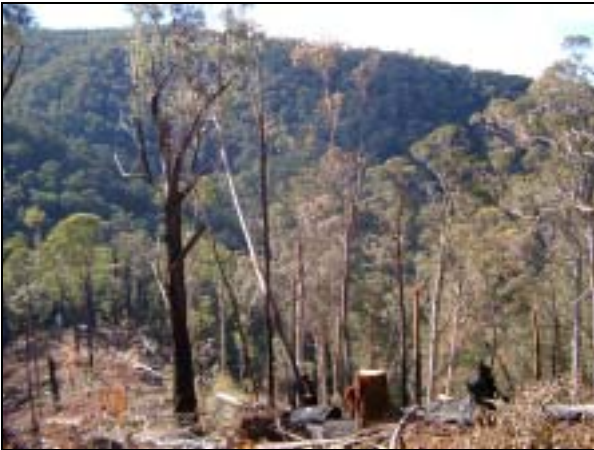
Photo 19. Hung up tree felled in coupe.

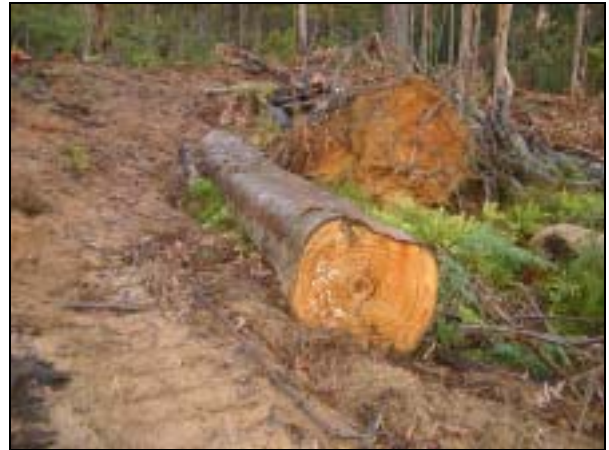
Photo 22. Grade C messmate log left in coupe.

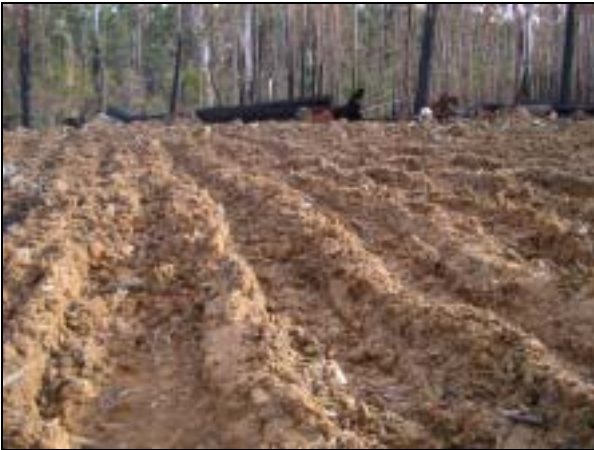
Photo 20. Damage to soil structure from ripping of coupe during wet weather.

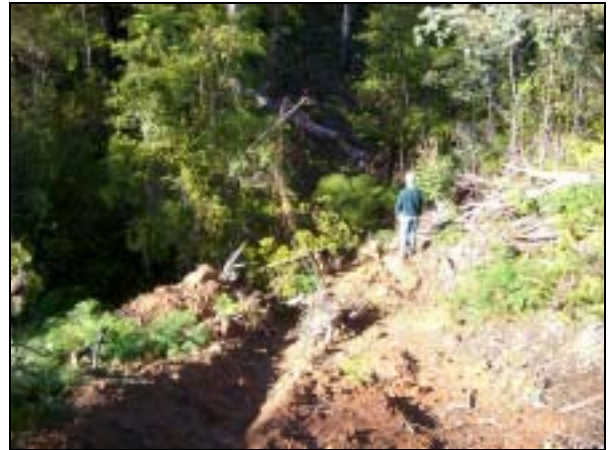
Photo 23. Damage from a tree that had been felled into the buffer and then retrieved without approval.

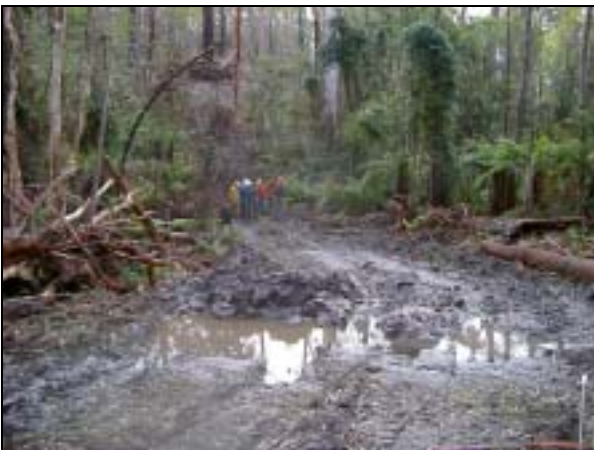
Photo 21. Boundary track installed through filter strip by DSE after completion of harvesting.

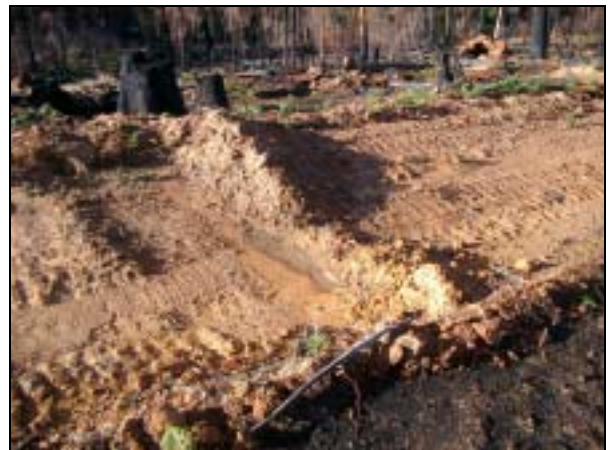
Photo 24. An ineffectual cross-drain. The bar is perpendicular to the road alignment and slopes back from the breach visible in the upper section of the photograph.
