# ENVIRONMENTAL AUDIT REPORT, 1-3 HIGH STREET YARRAVILLE - PHOTOS

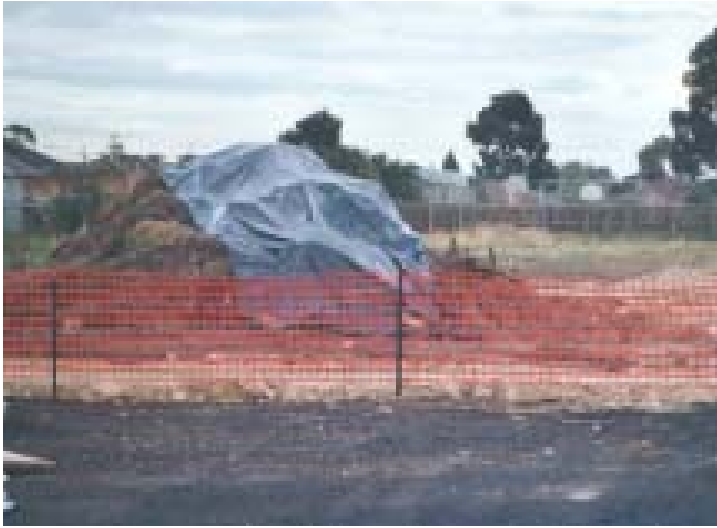
7. Stockpiled vegetation and soil removed during surface scrape (15/4/02)

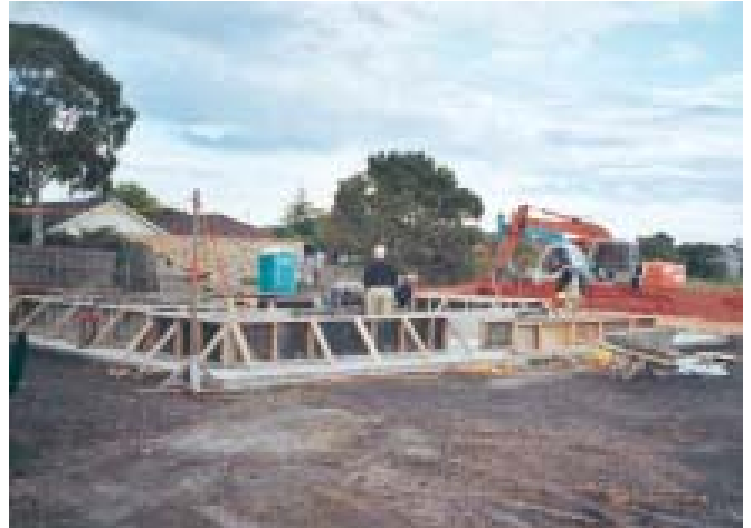
8. Clean area formed for concrete panel fabrication (15/4/02)

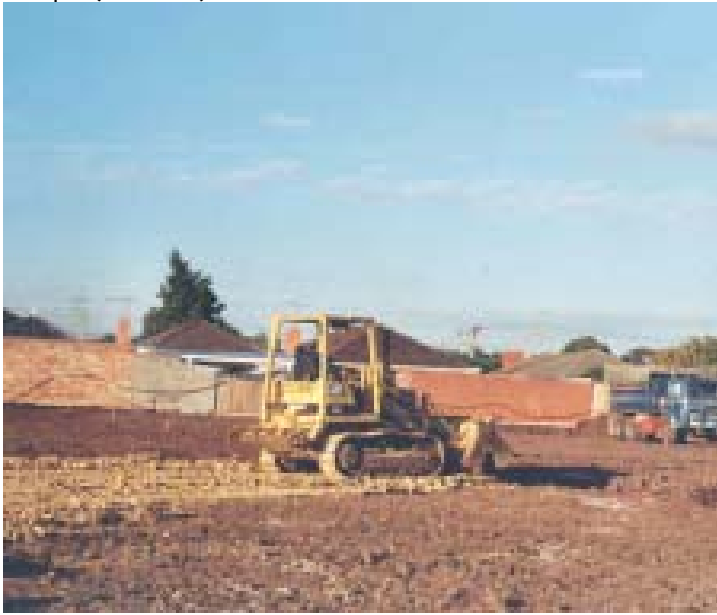
9. Preparing subgrade (forming to starting levels) (6/5/02)

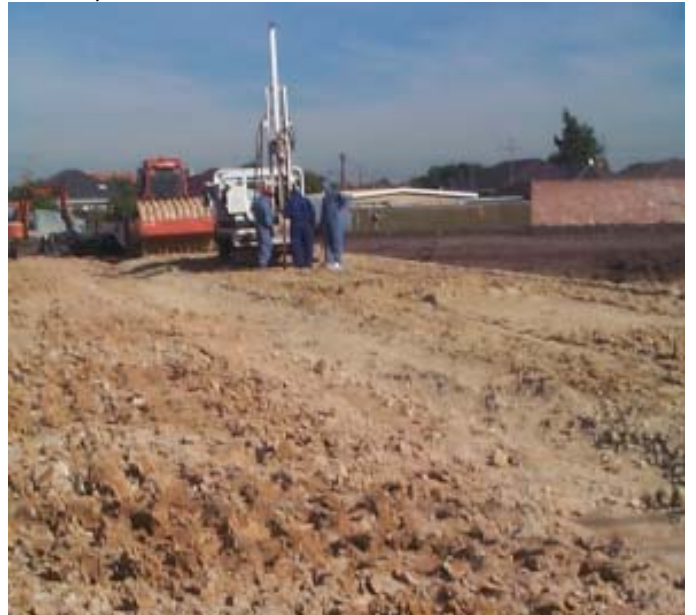
10. Testing of test pad used to confirm performance of clay (7/5/02)

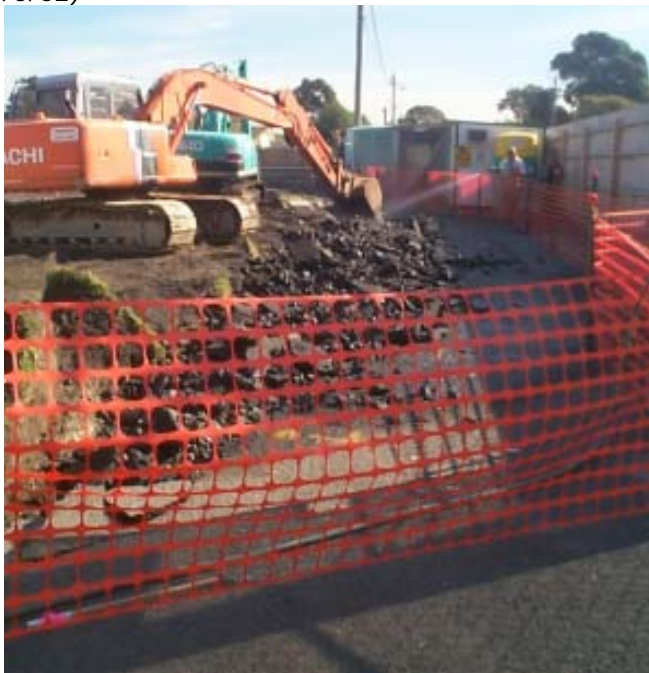
11. Excavation to determine edge of quarry beneath High Street (7 May 2002)

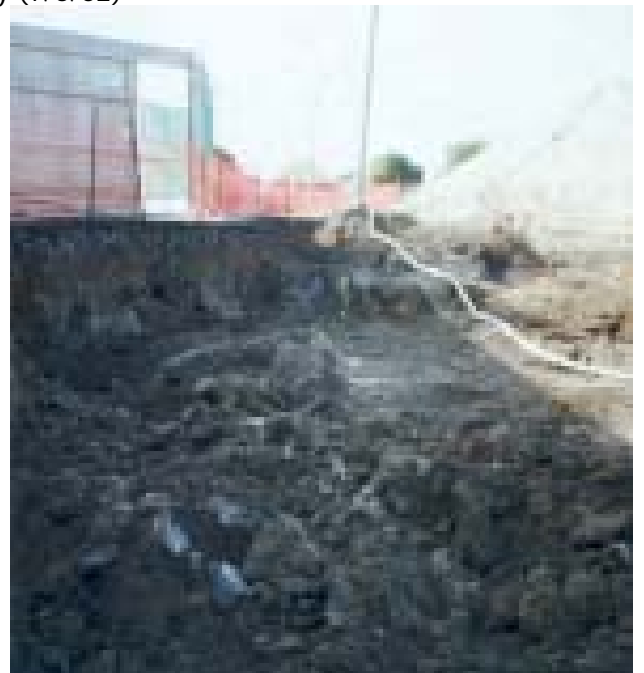
12. Exposing quarry edge beneath High St (15/5/02)

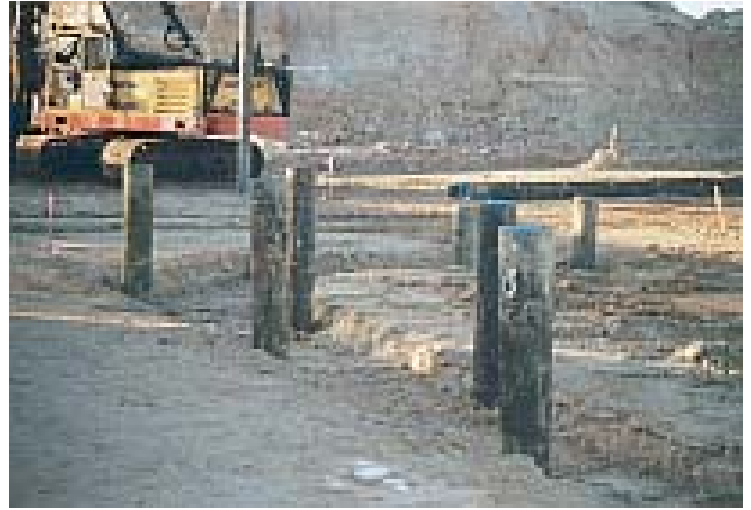
14. Piling for construction of retaining wall along High St (18/6/02)

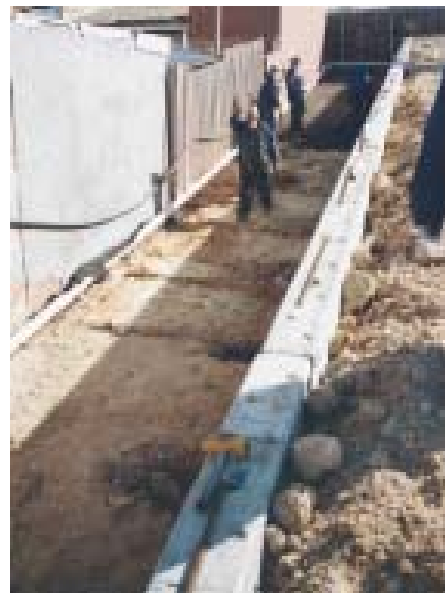
16. Retaining wall and cap construction along southern boundary (31/7/02)

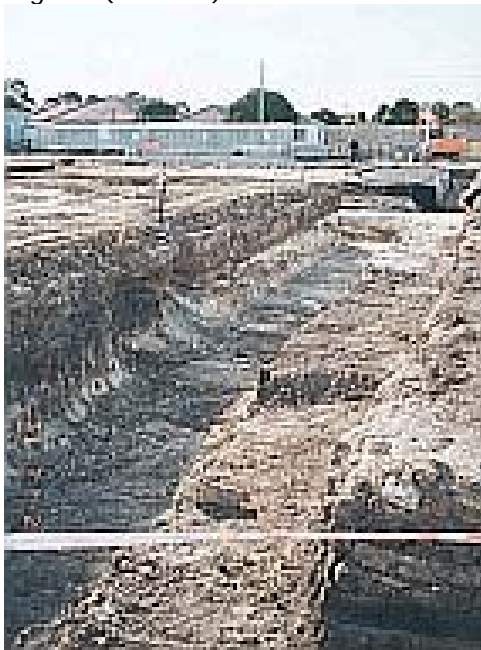
17. Trench excavated to allow clay to be installed around services (31/7/02)

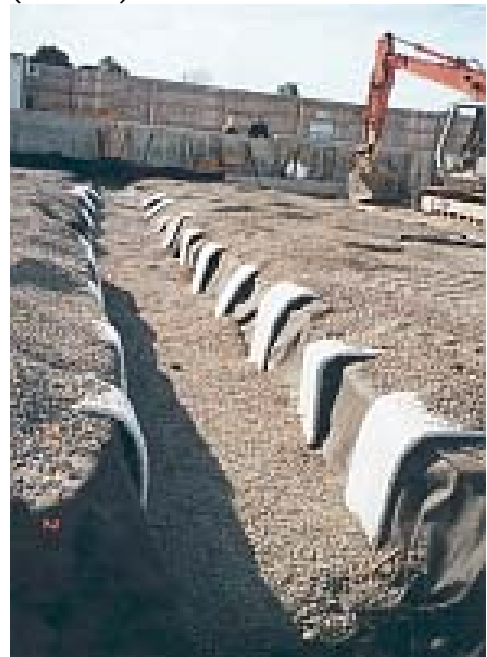
18. Construction of gas ventilation along service trench (31/7/02)

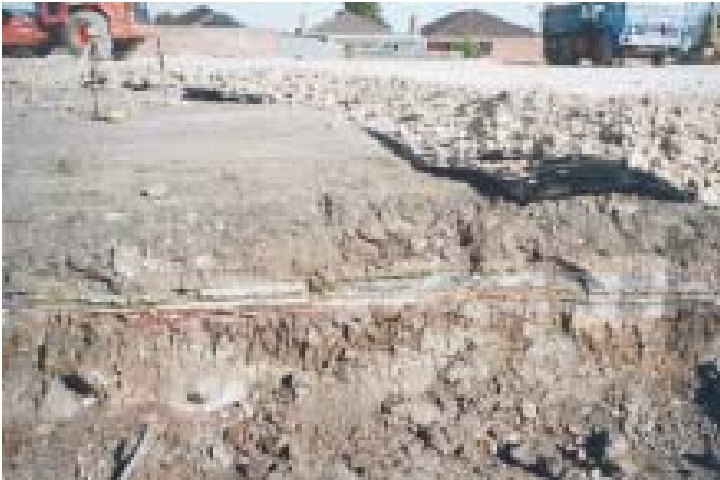
19. Installation of clay cap (including gas vent layer and geosynthetic fabric) (31/7/02)

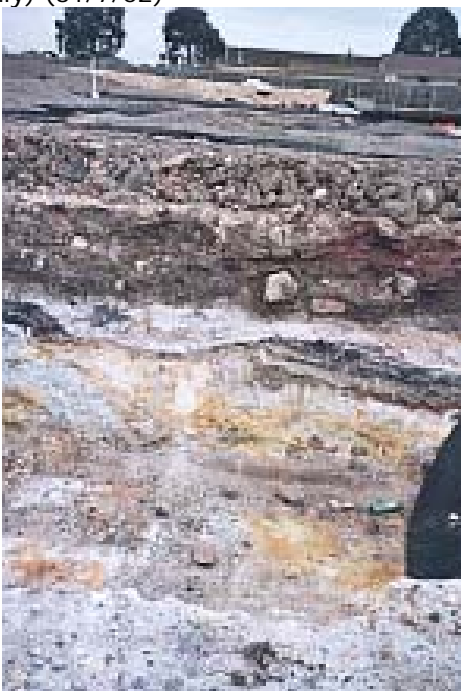
23. Typical profile beneath cap (9/8/02)

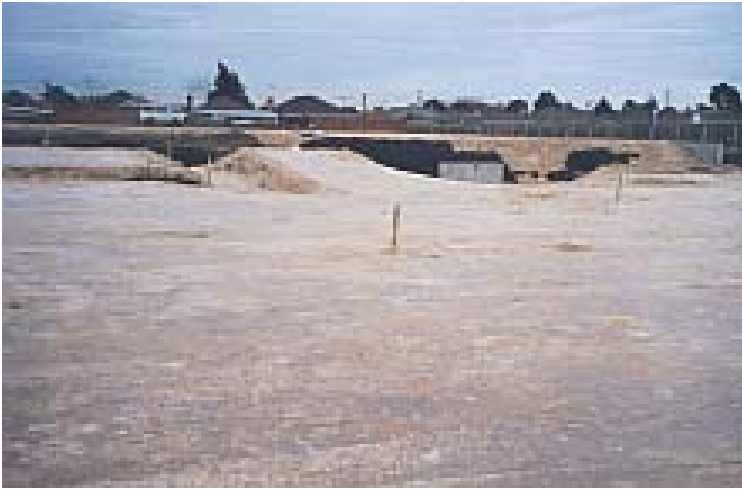
25. Clay capping on western segment of site (9/8/02)

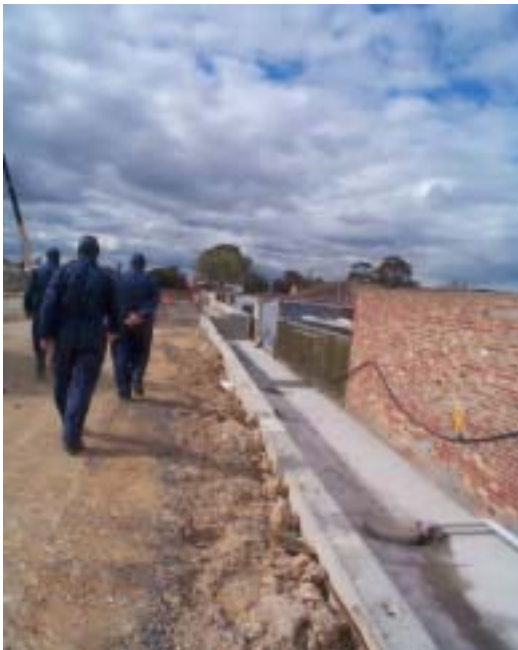
29. Retaining wall, cap and finished surface on southern boundary) (20/8/02)

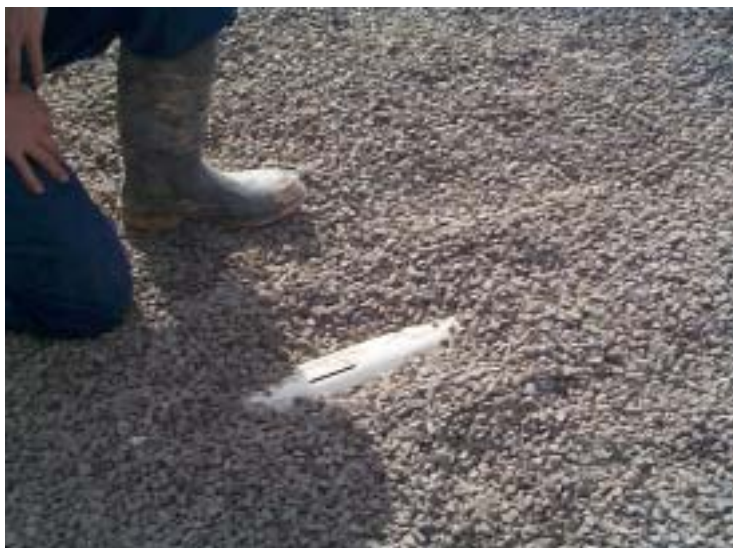
30. Horizontal gas collectors in gas vent layer beneath super market (20/8/02)

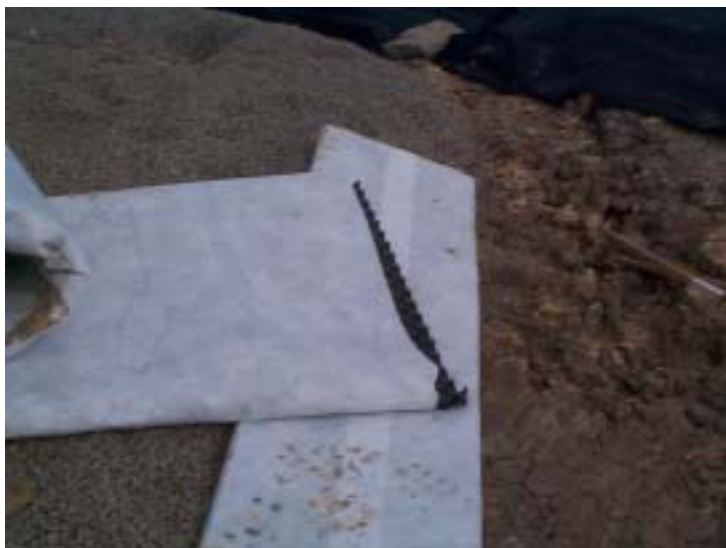
31. Strip drain material used to construct gas vent layer in trenches (20/8/02)

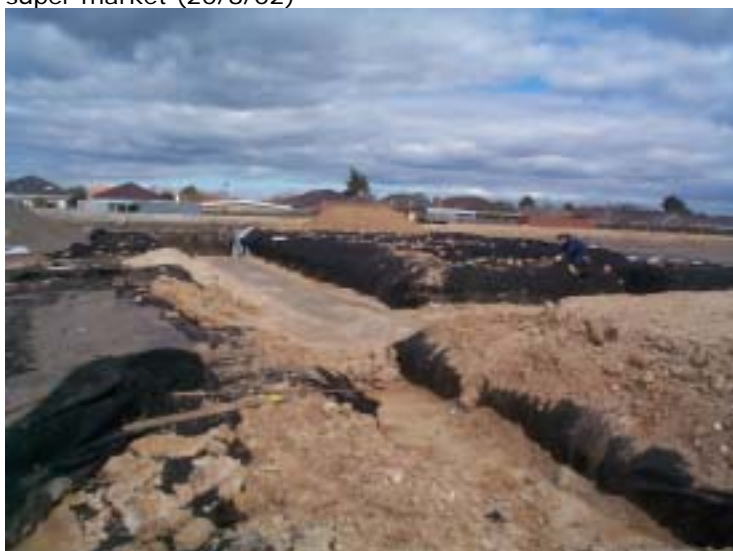
32. Compacted clay within trenches (20/8/02)

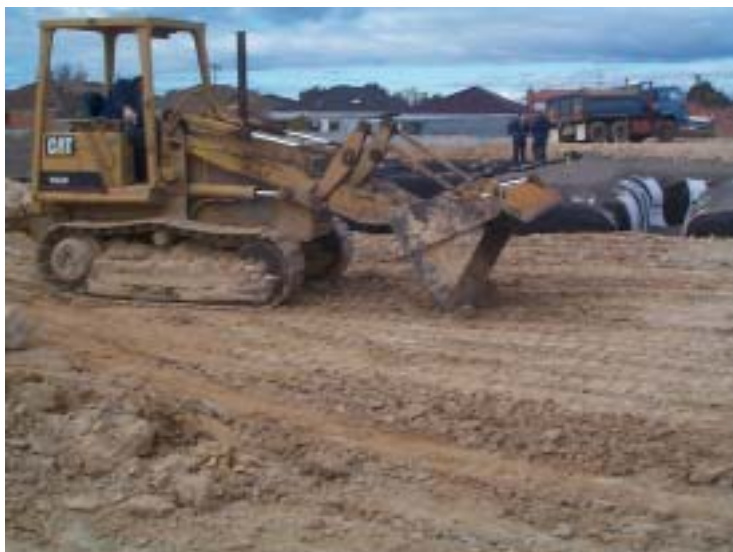
34. Scarifying surface of compacted clay layer prior to placement of next lift of clay (20/8/02)

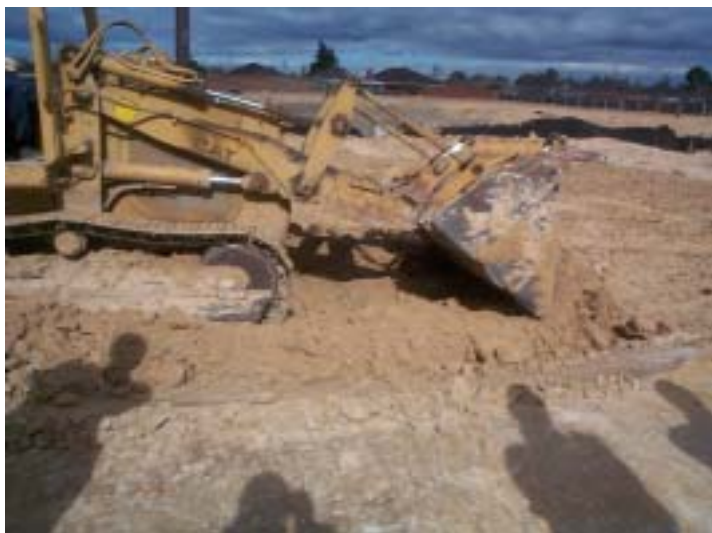
36. Placing next lift of clay for compaction (20/8/02)

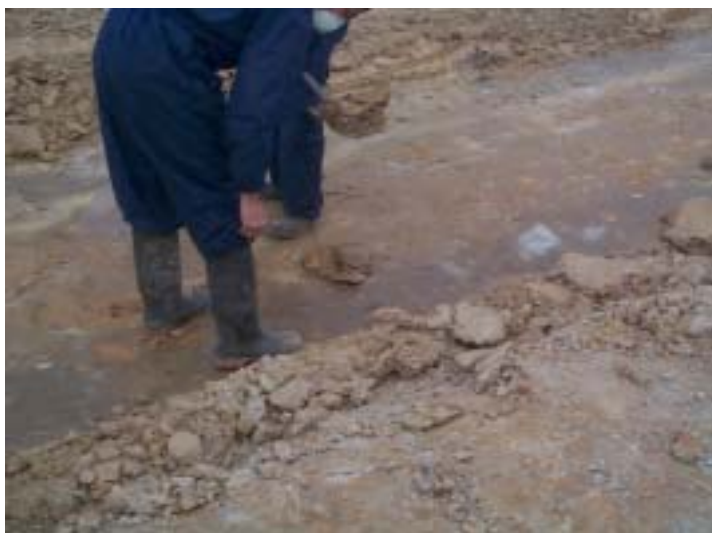
38. Collection of sample of compacted clay for testing (20/8/02)

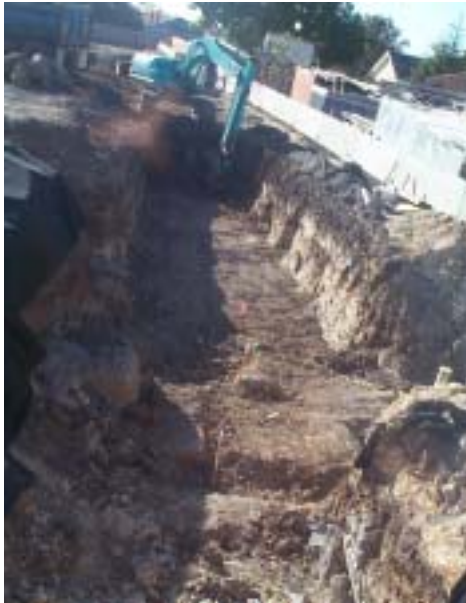
41. Excavation of service trench along southern boundary (25/9/02)

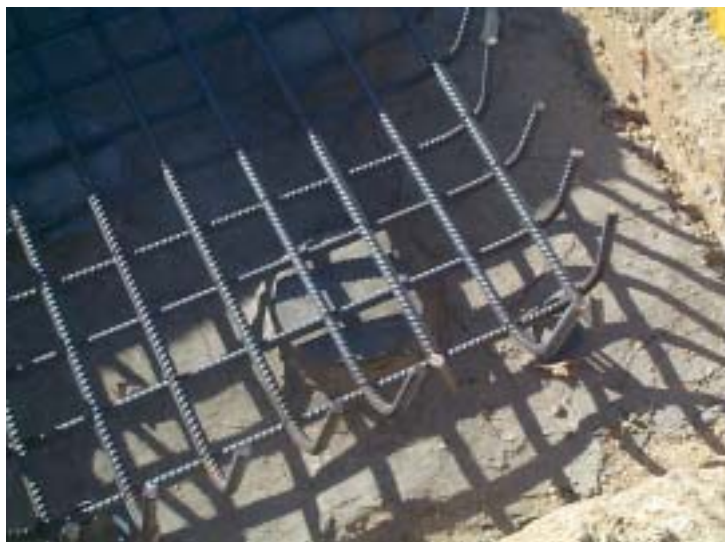
47. Steel reinforcement for pile cap above pile sealed with expanding grout (25/9/02)

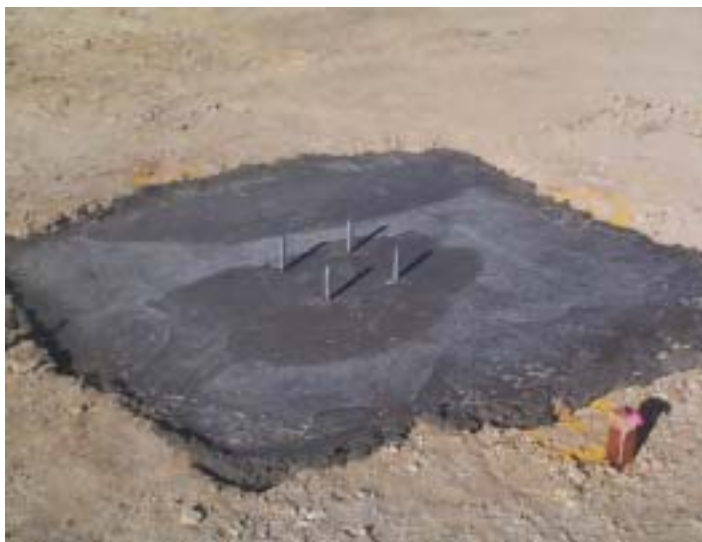
48. Finished pile cap (25/9/02)

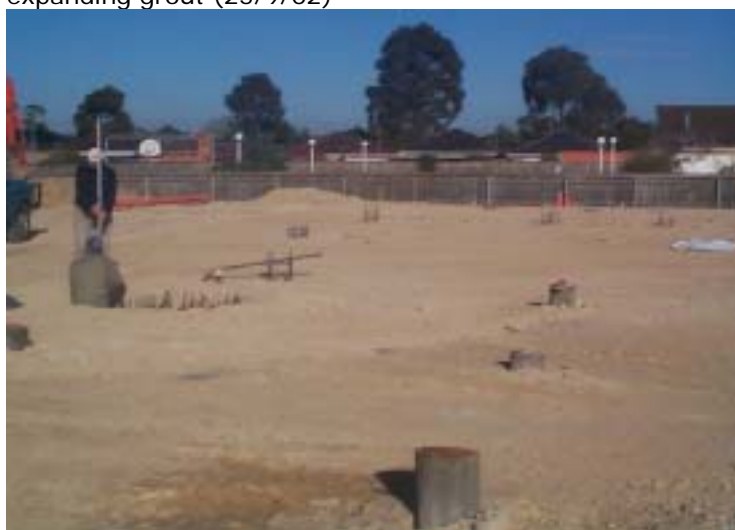
49. Piles beneath supermarket (25/9/02)

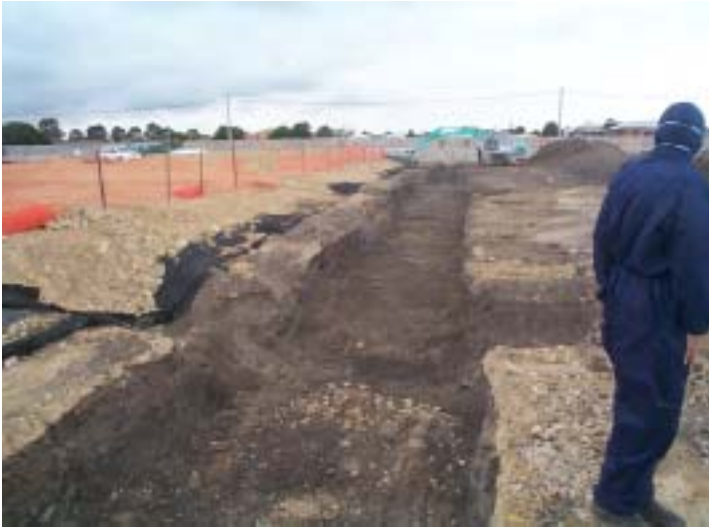
50. Excavation of service trenches (for placement of clay) in eastern portion of the site (28/10/02)

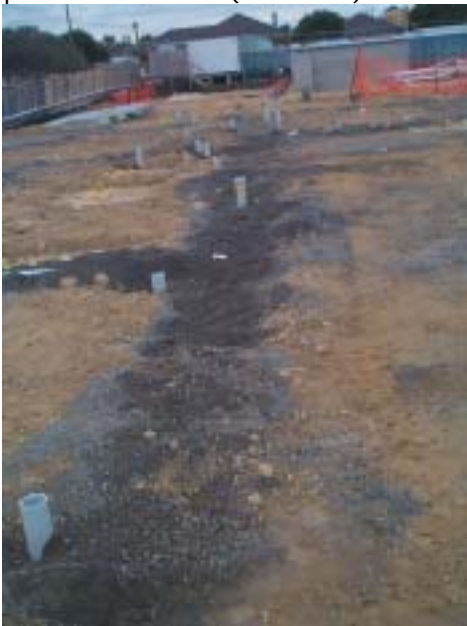
52. Services installed in trenches beneath supermarket where cap was locally thickened (28/10/02)

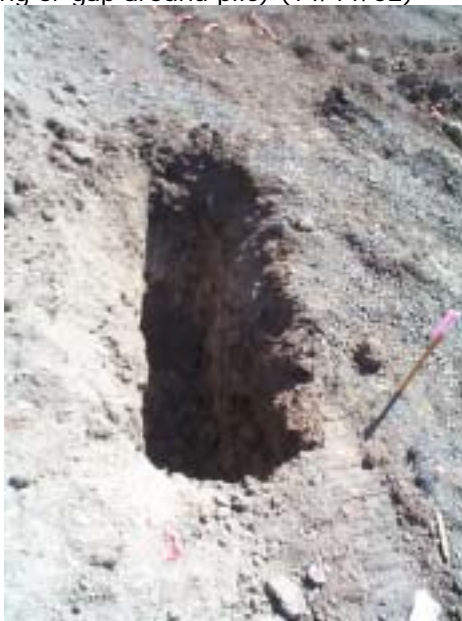
58. Test pits used to sample soil along eastern boundary of site (near location of burial of contaminated soil on-site) (14/11/02)

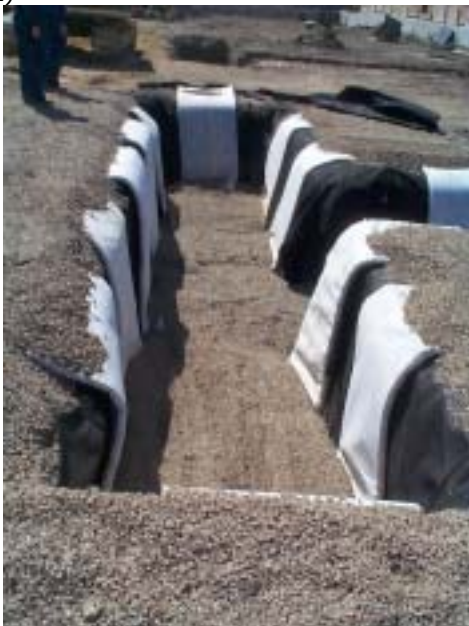
60. Construction of gas vent layer in trench in east section of site (14/11/02)

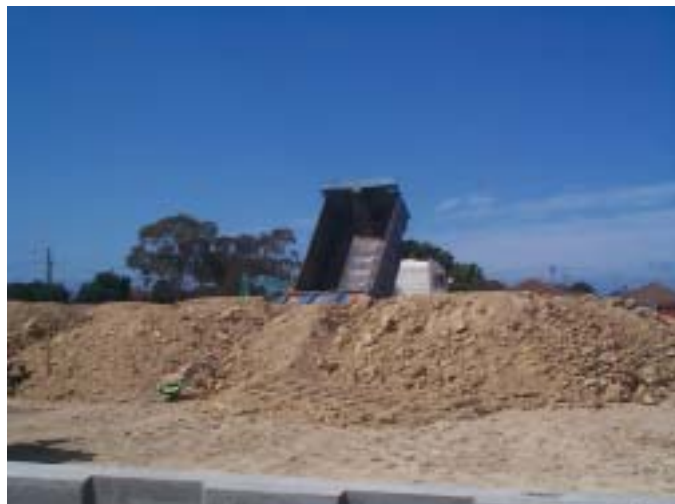
63. Clay from Carlton construction site arriving on-site (14/11/02)

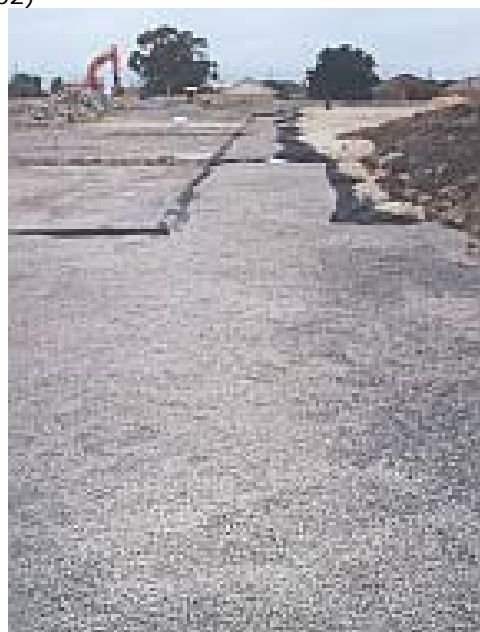
65. Construction of gas vent layer and clay cap on east section of the site (14/11/02)

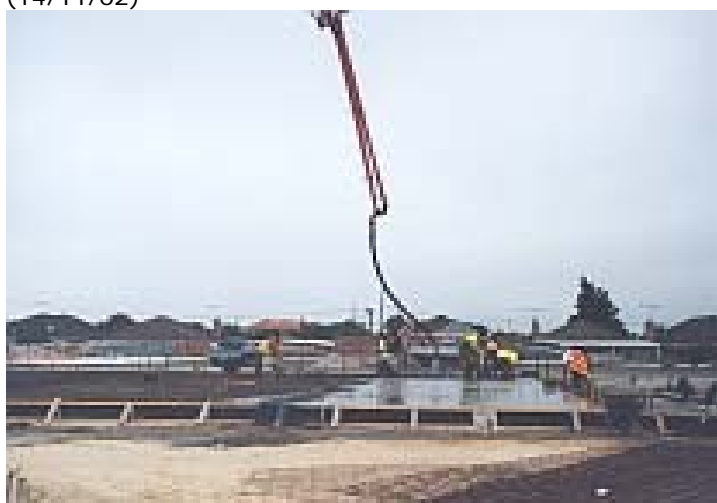
66. Pouring concrete slab in supermarket area (18/12/02)

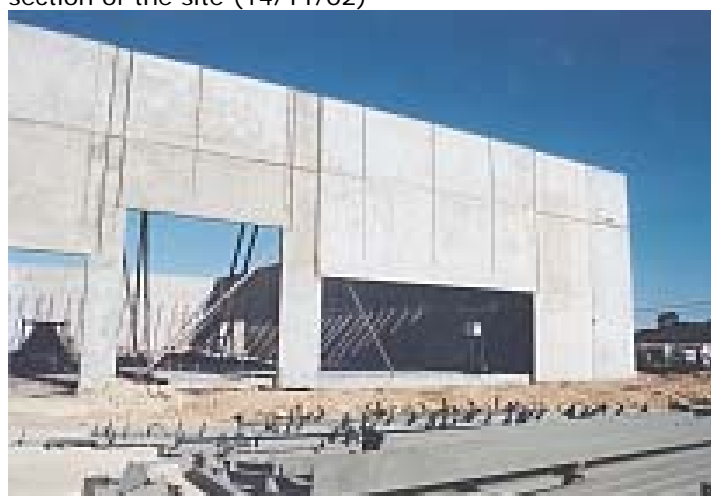
67. Construction of supermarket (12/2/03)

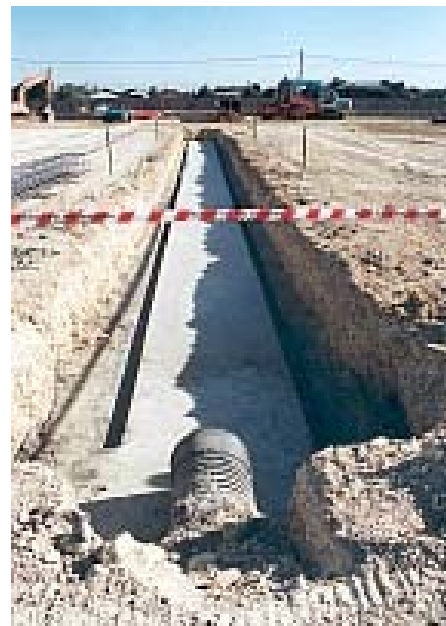
69. Major service trench excavated into thickened clay (12/2/03)

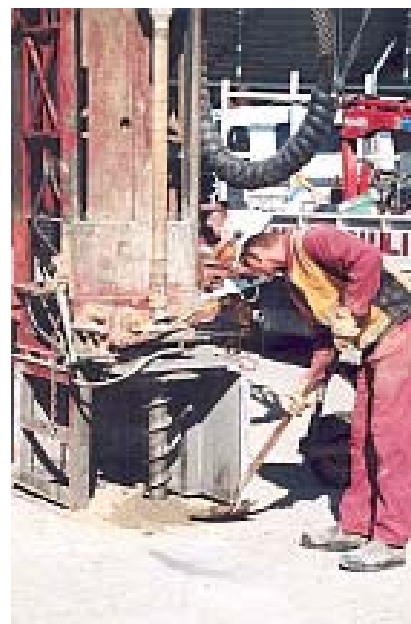
71. Drilling for groundwater monitoring bore within quarry (5/4/03)

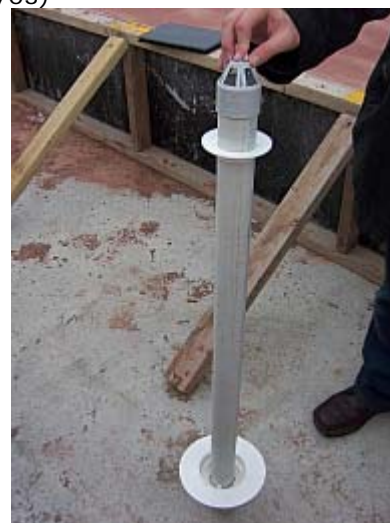
73. Gas vent assembly (17/6/03)

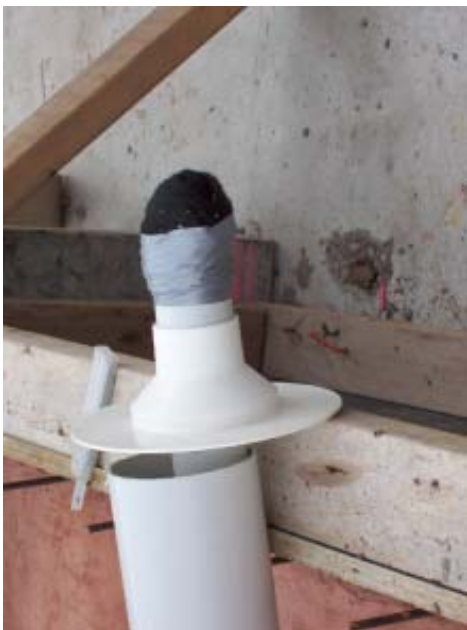
74. Bottom of gas vent assembly (17/6/03)

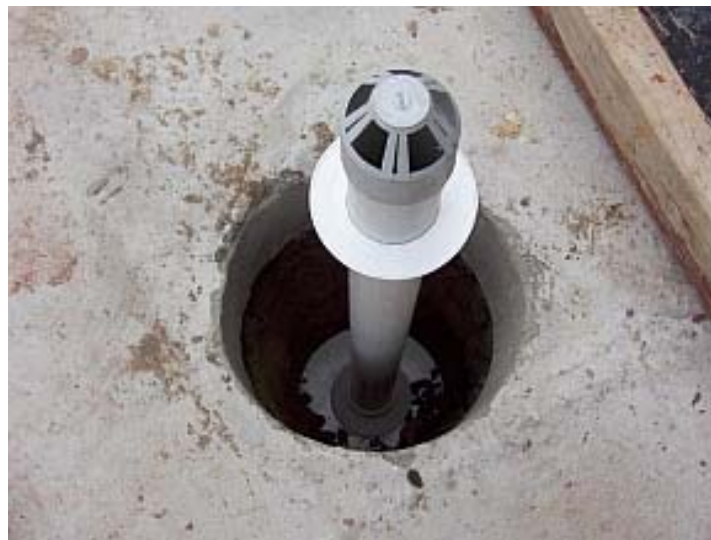
75. Installed gas vent (not sealed) (17/6/03)

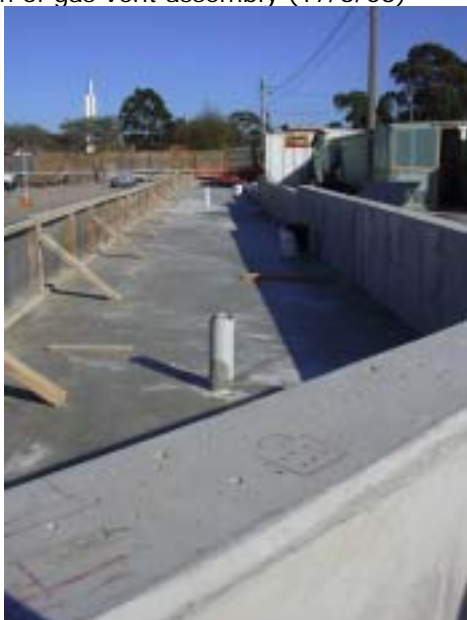
76. Gas vents installed within garden area (4/4/03)

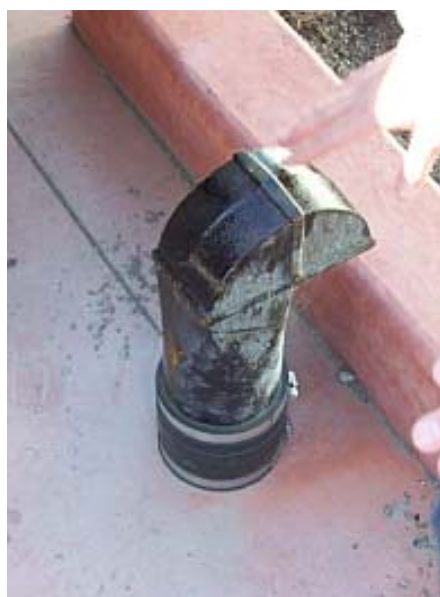
78. Finished gas vent (4/9/03)

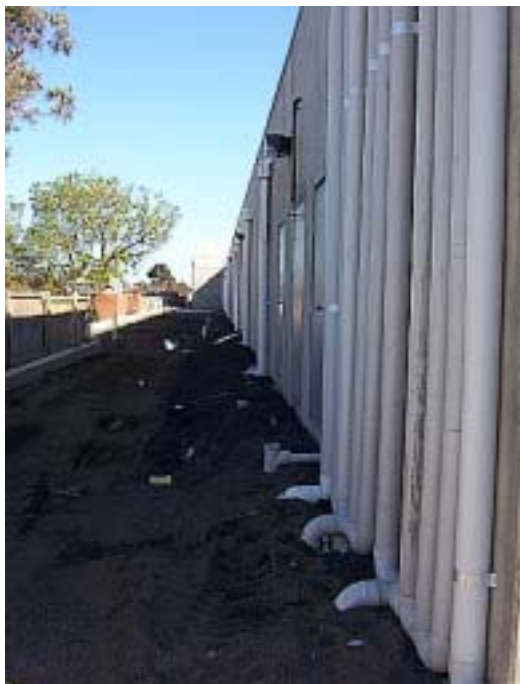
80. Gas vents stacks (4/9/03)

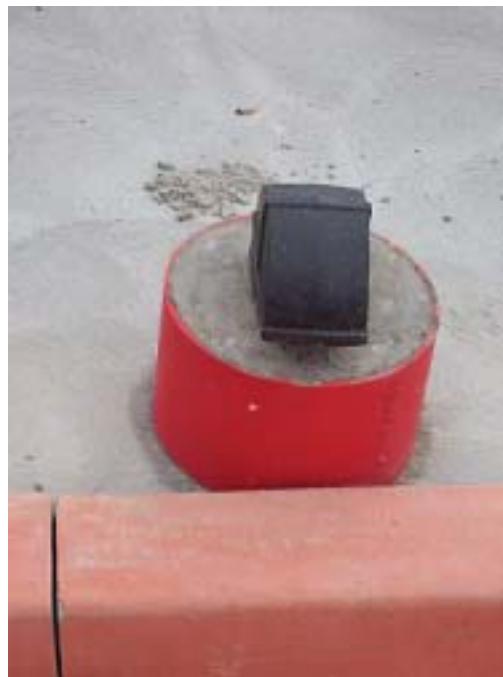
81. Finished gas vent in carpark (21/10/03)

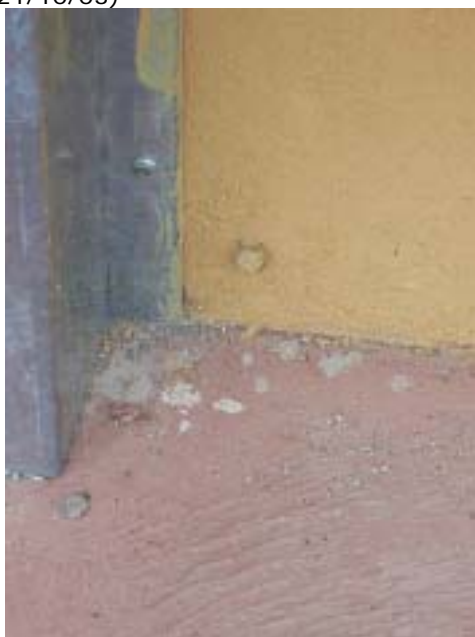
84. Survey point to measure settlement (21/10/03)

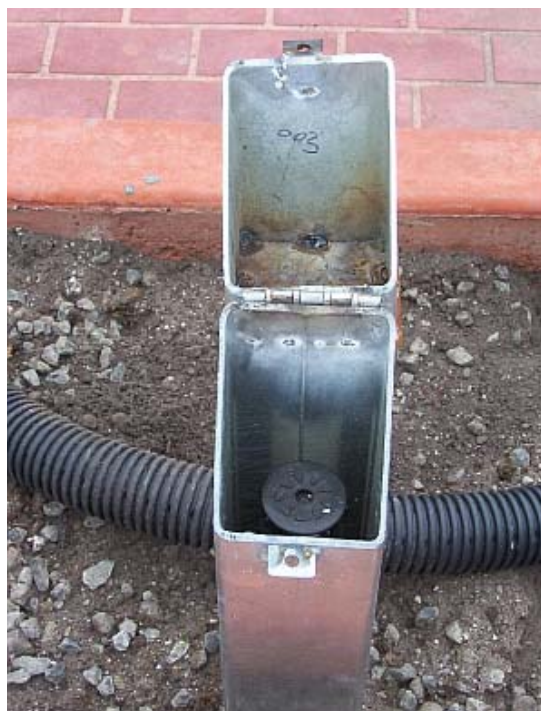
86. Finished groundwater monitoring bore (21/10/03)
