# ENVIRONMENTAL AUDIT REPORT, 1-3 HIGH STREET YARRAVILLE - PHOTOS

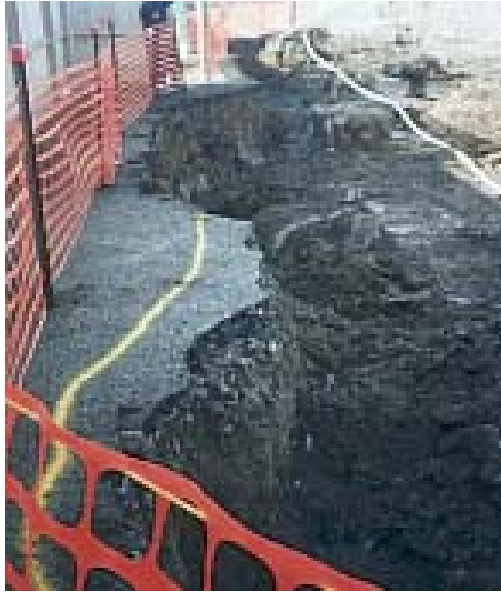
13. Determining quarry edge beneath High St (15/5/02)

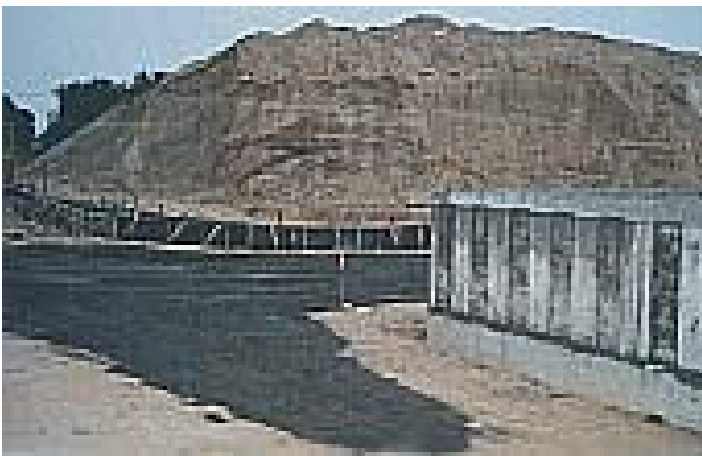
15. Retaining wall along High St and capped area beneath High St (16/7/02)

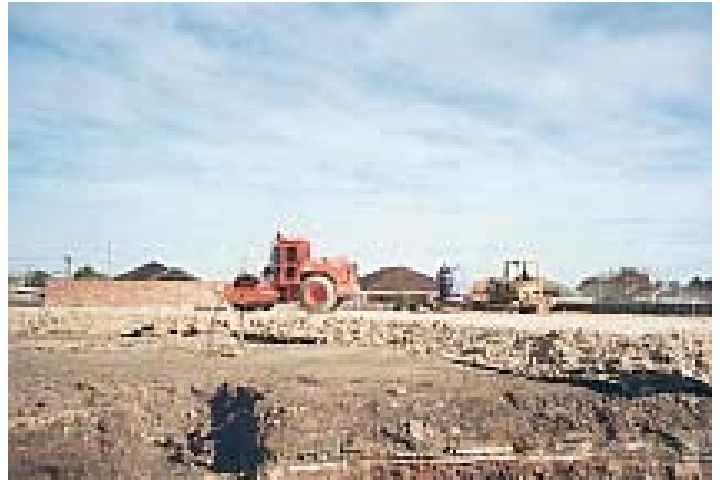
20. Compaction of clay cap (31/7/02)

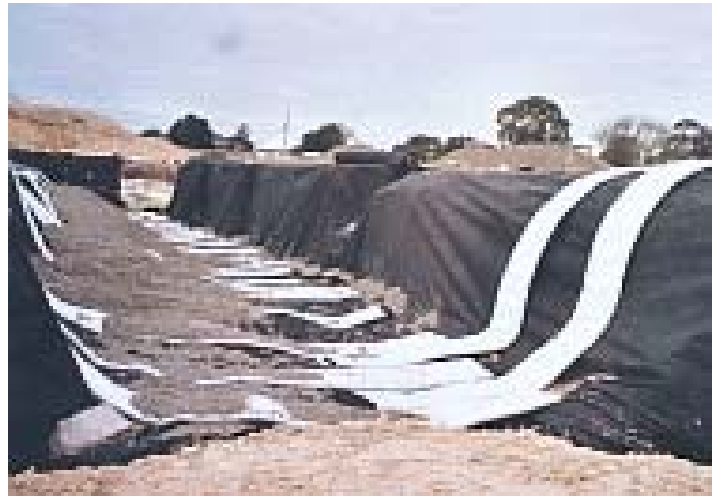
22. Use of strip drain to construct gas vent layer in trenches (9/8/02)

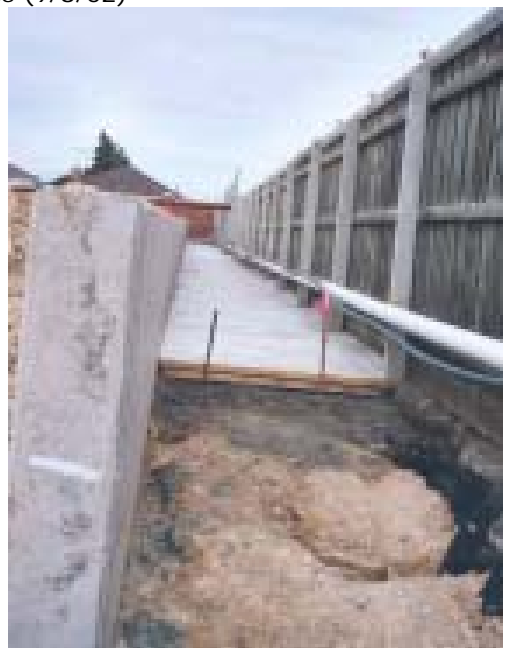
24. Finished surface on western boundary (no clay cap) (9/8/02)

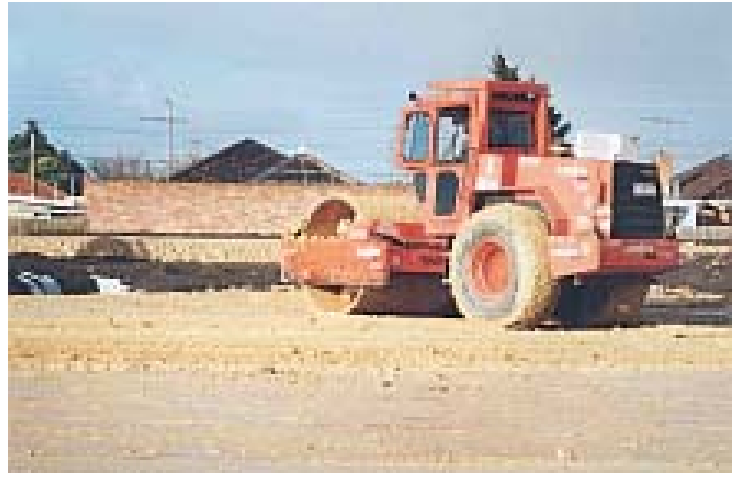
26. Compaction of clay using smooth drum (pad foot roller used to key in layer) (13/8/02)

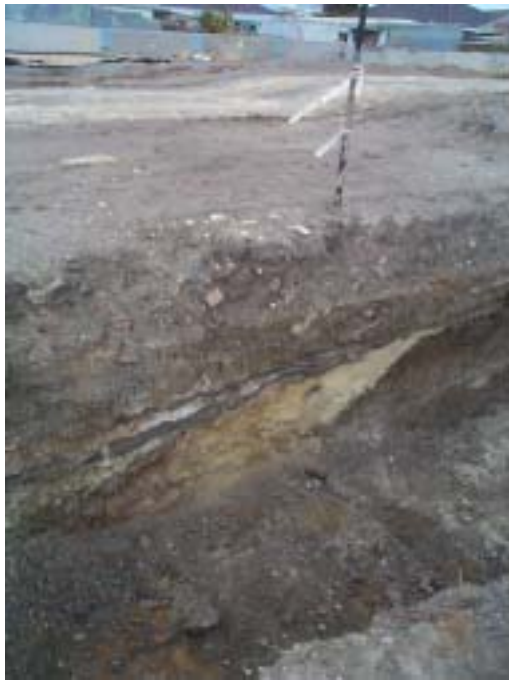
27. Typical fill profile (20/8/02)

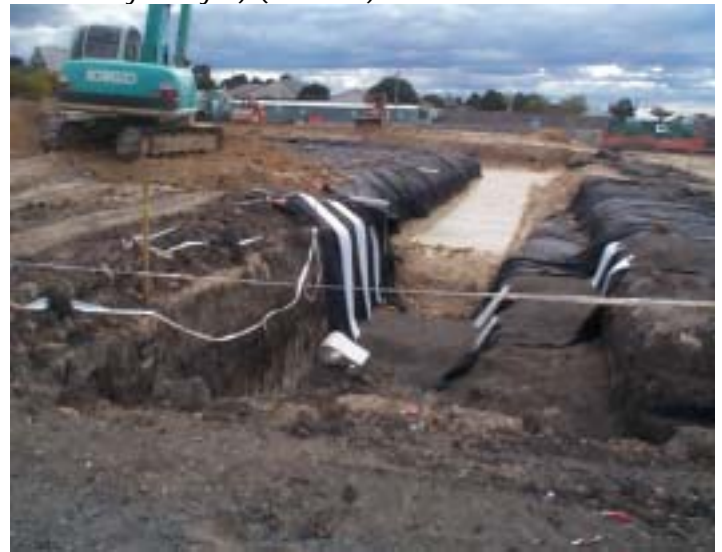
28. Clay cap installed within trench (service trenches later excavated in clay) (20/8/02)

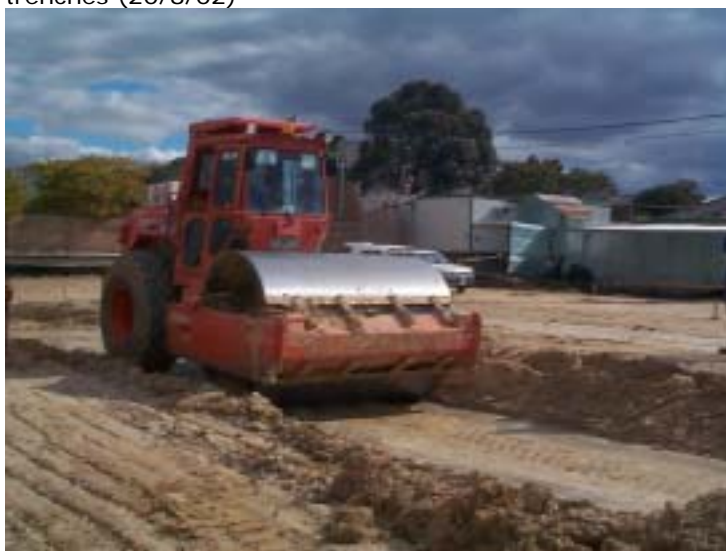
33. Compaction of clay lift using vibrating drum roller (20/8/02)

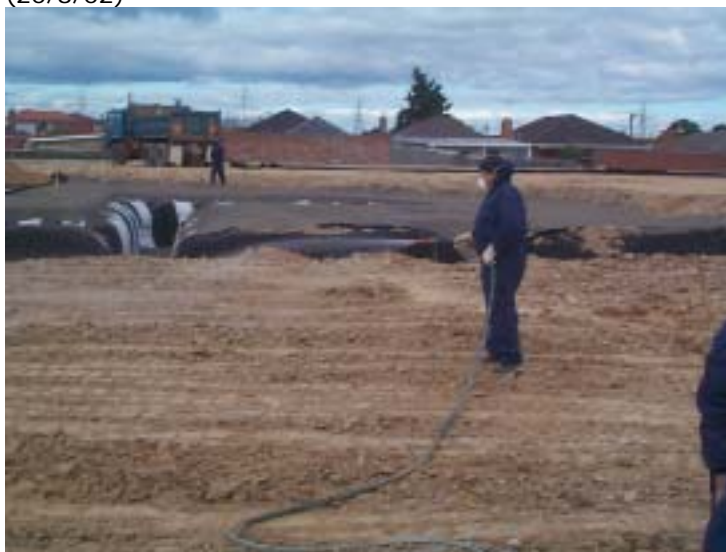
35. Wetting of scarified surface of clay prior to placement of next lift of clay (20/8/02)

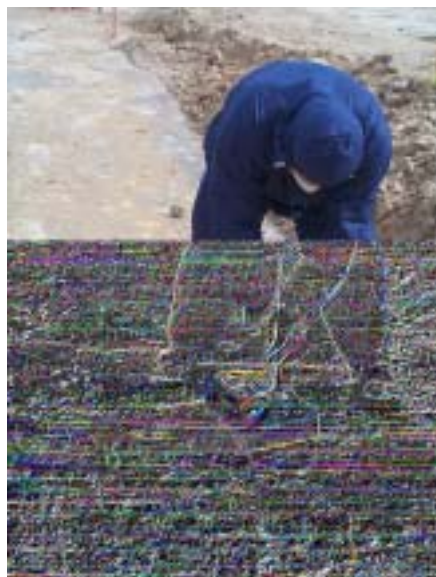
37. Compaction density testing of compacted clay (20/8/02)

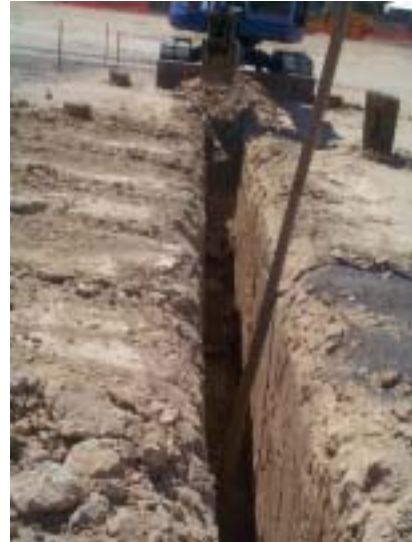
51. Sewer trench being excavated in compacted clay beneath supermarket (14/11/02)

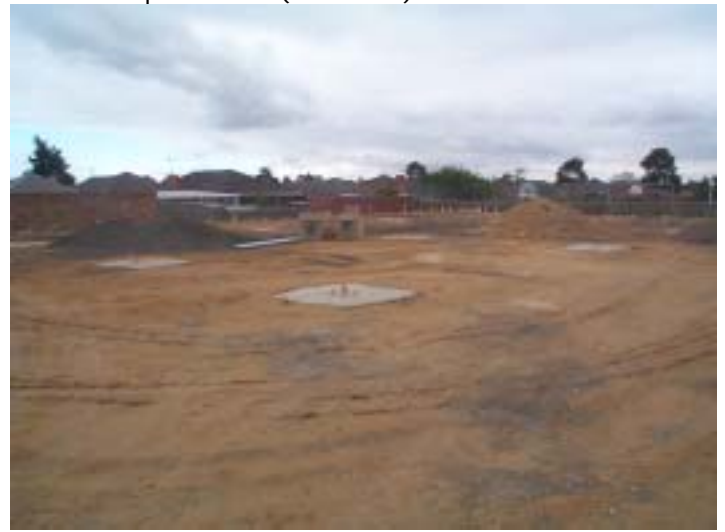
53. Finished clay cap and pile caps beneath supermarket (28/10/02)

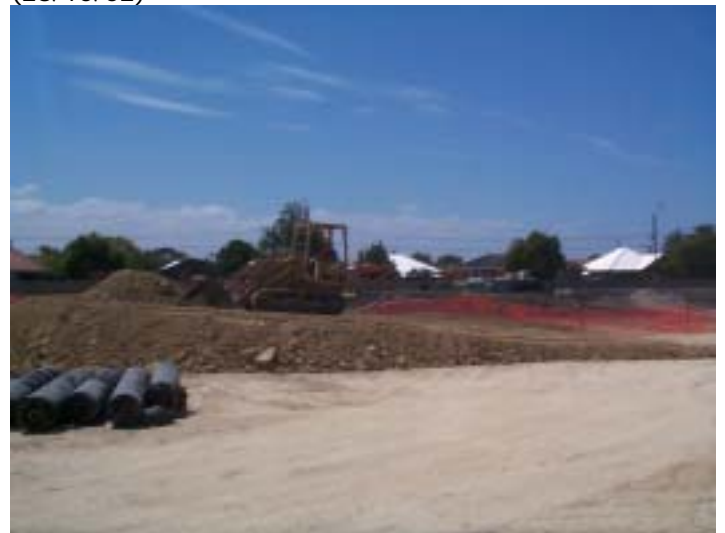
55. Stockpiled clay from "Carlton" source (14/11/02)

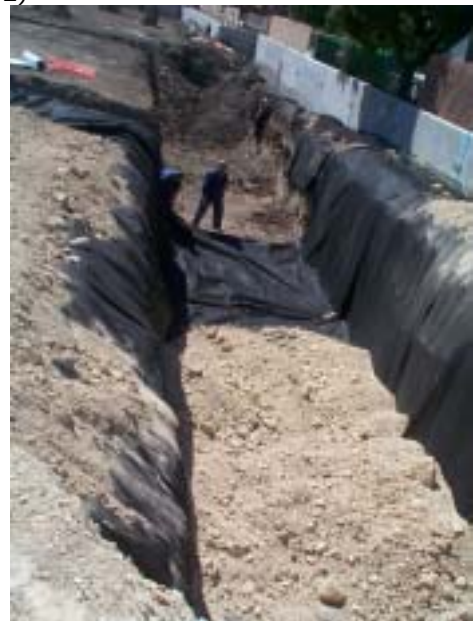
59. Placing clay in major service trench along southern boundary (14/11/02)

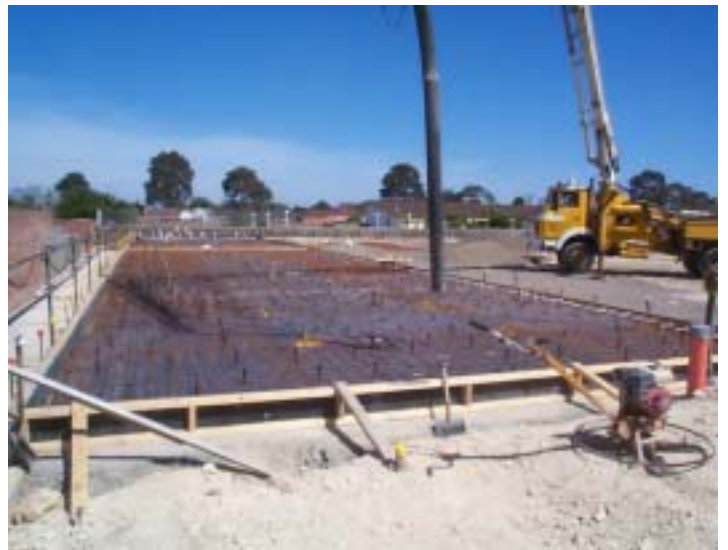
61. Pouring slab for shopping centre (14/11/02)

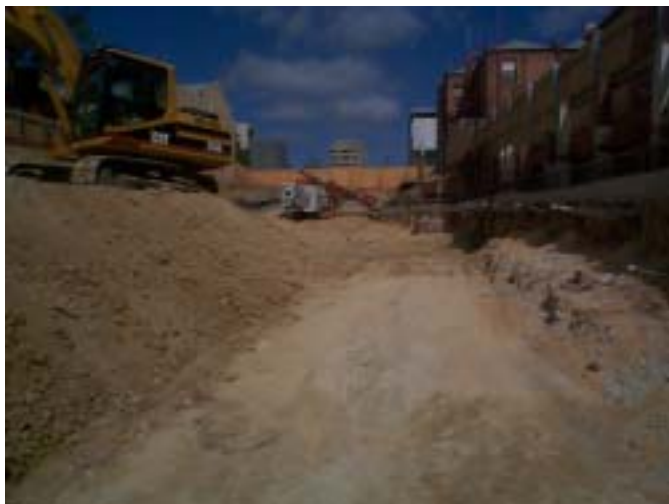
62. Carlton construction site (14/11/02)

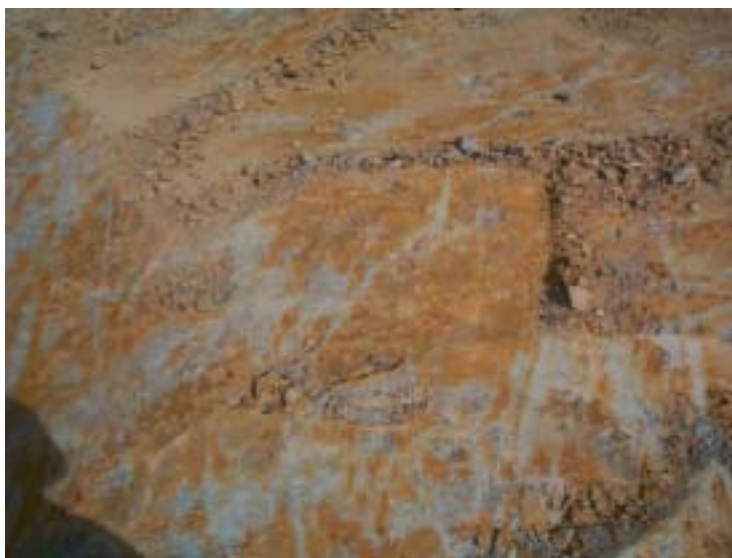
64. Compacted clay at Carlton construction site (14/11/02)

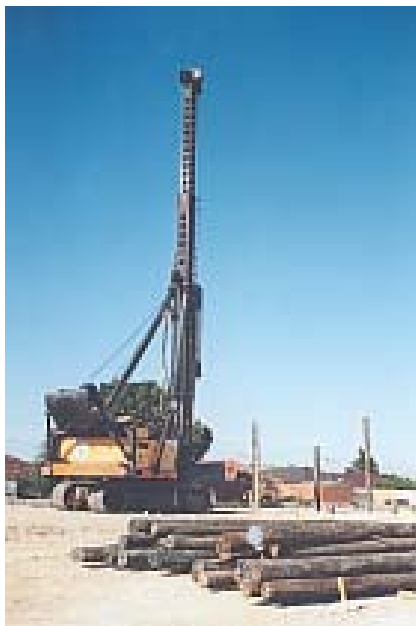
68. Piling rig and timber piles (12/2/03)

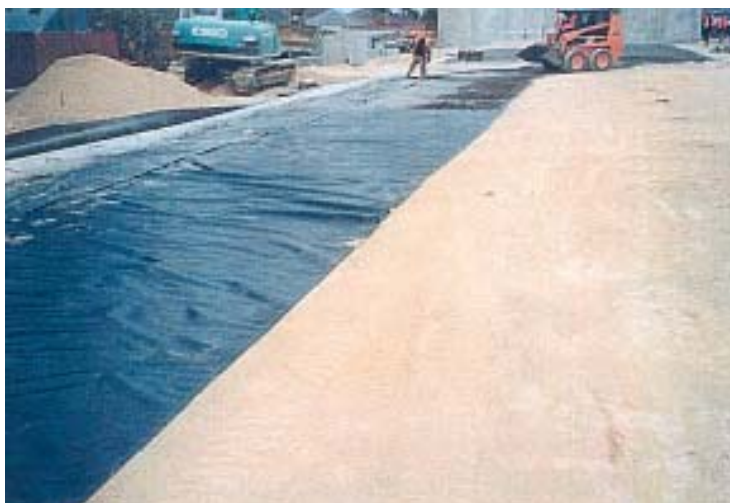
70. Placement of Tensar (4/4/03)

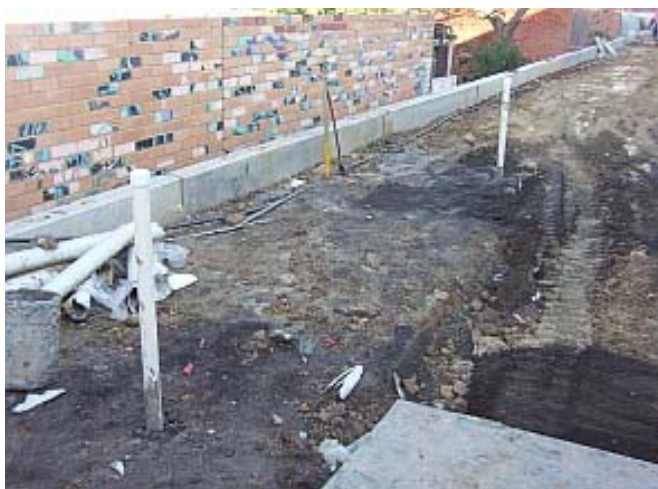
72. Groundwater monitoring bores on southern boundary (11/6/03)

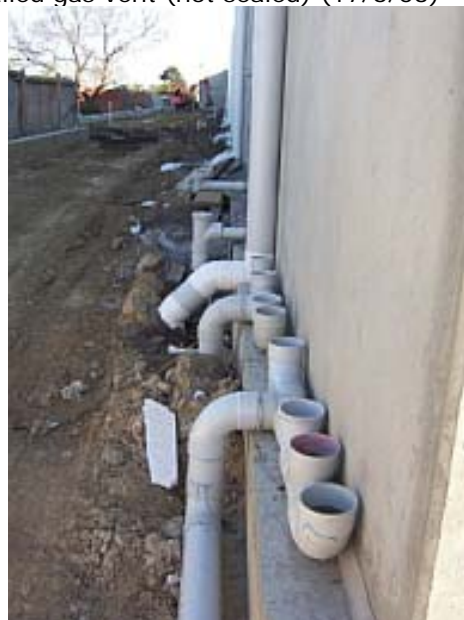
77. Gas vent pipework at rear of specialty shops (connected to lateral vents beneath building) (11/6/03)

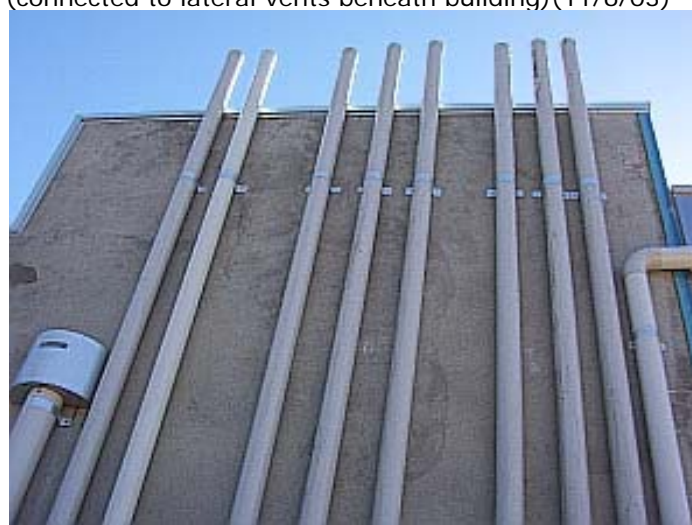
79. Gas vent stacks (4/9/03)

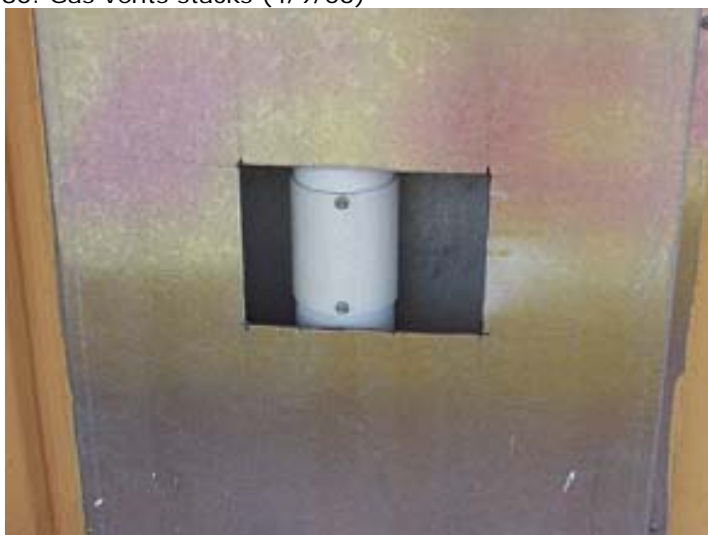
82. Provision for sampling from gas vents from beneath building (21/10/03)

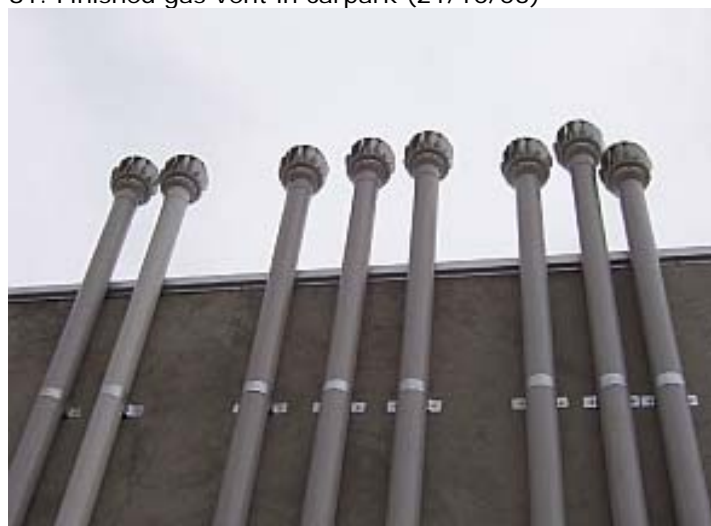
83. Rotary vents connected to gas ventilation layer (21/10/03)

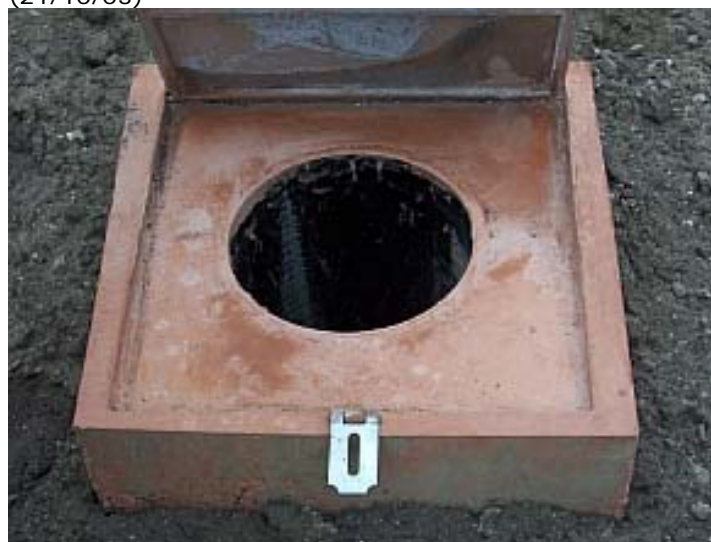
85. Subsurface chamber to monitor any gas above clay layer (21/10/03)

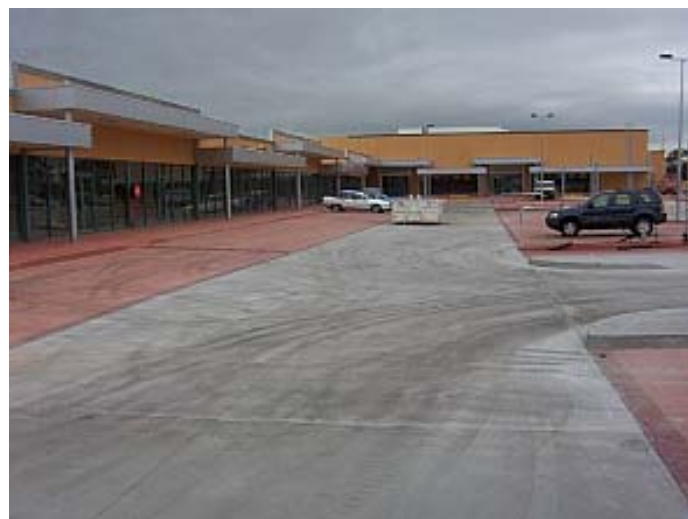
87. General site view (21/10/03)

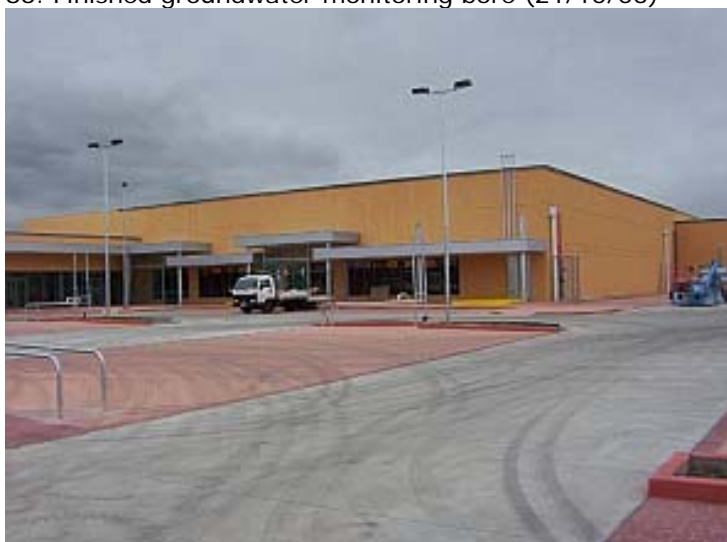
88. General site view (21/10/03)
